DENSO™ STEELCOAT CUI CONTROL SYSTEM

The Denso Steelcoat CUI Control System offers high performance protection ideal for controlling a very common corrosion problem

PUB No. 528.10.2020

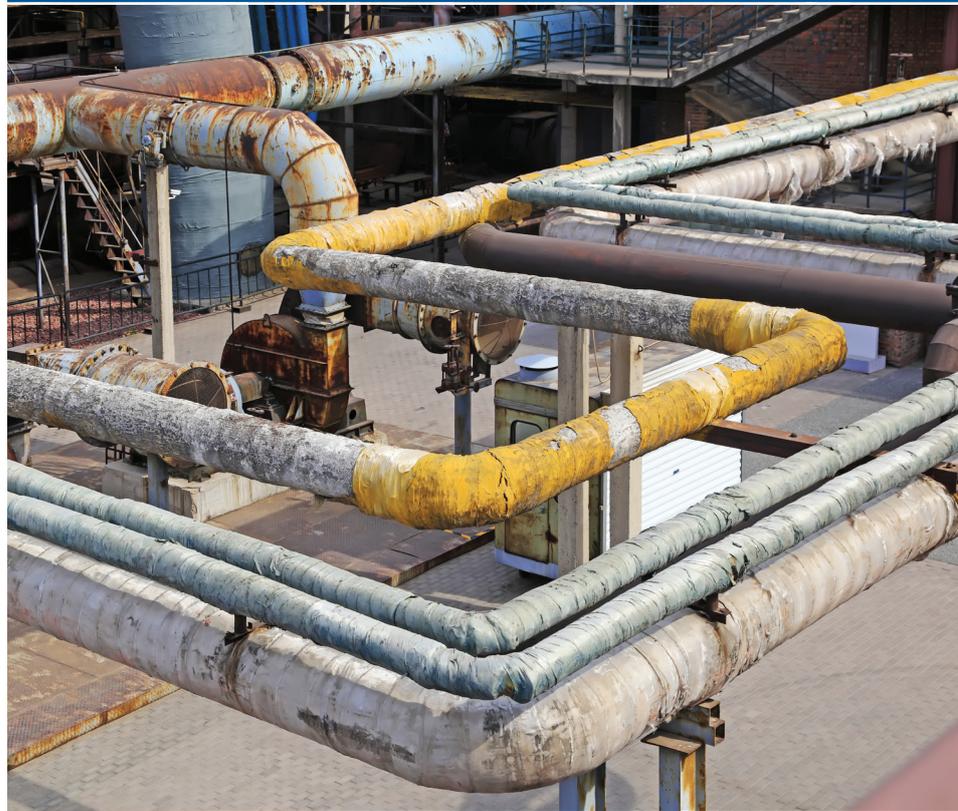
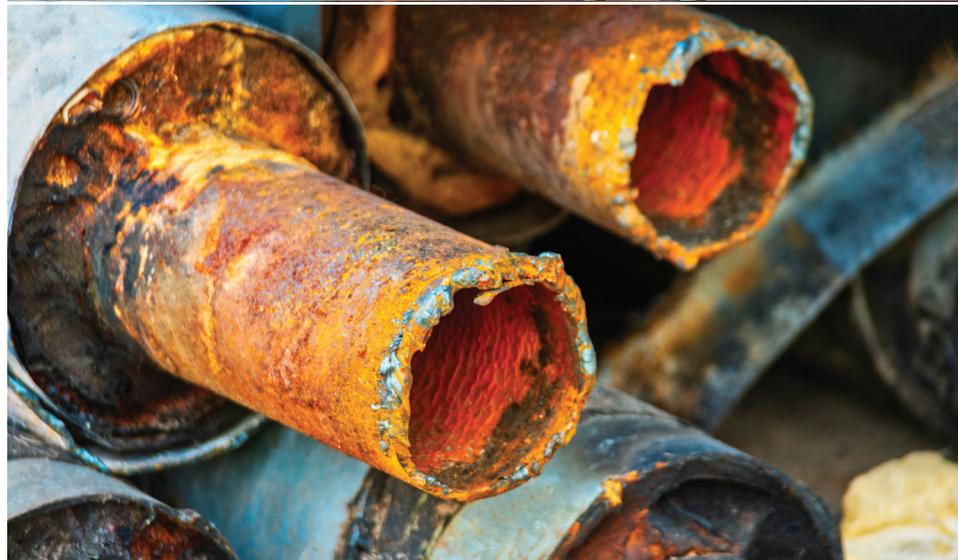
Although insulated pipes can look like they are in a satisfactory condition from the outside, the insulation often hides corrosion which is only seen when it is removed for inspection!

Typical hidden corrosion damage which is often only revealed by removing the pipe insulation!

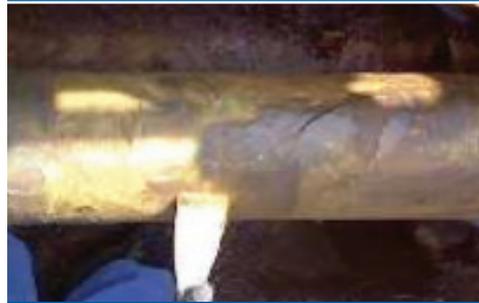
Steelcoat CUI Control System 2:
First a layer of Denso Paste...

For service temperatures -30°C to +70°C
Primer: Denso Paste™
Inner Layer: *Densyl™ Tape
Outer Layer: Denso Clear Wrap or Denso PVC Self-Adhesive Tape™

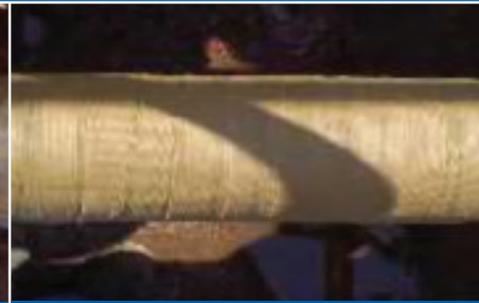
... is then followed by a layer of
Densyl Petrolatum Tape...

*Denso Hotline Tape and Densyl Tape are both applied with a 55% overlap.

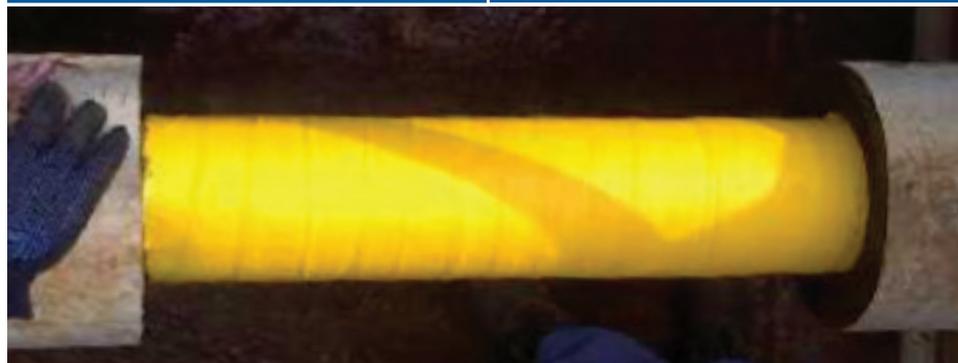
...which is followed by a final layer of Denso PVC Self-Adhesive Tape.

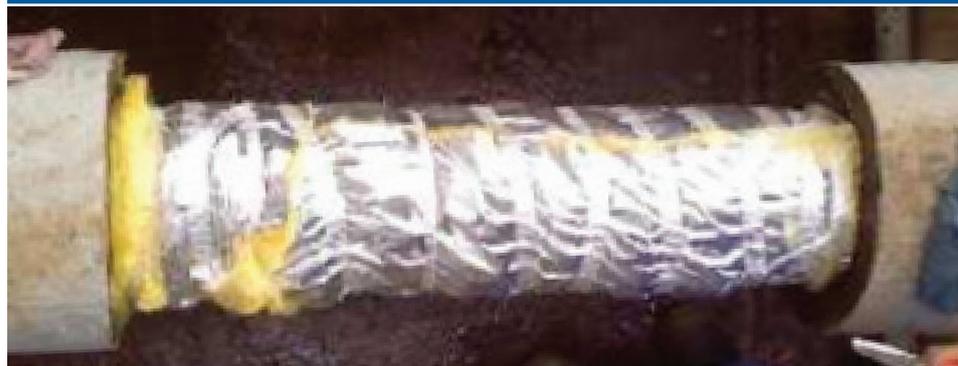
Steelcoat CUI Control System 2 - covered with fibre glass wool.
