Volume 31 - Number 3

LEADERS IN CORROSION PREVENTION & SEALING TECHNOLOGY

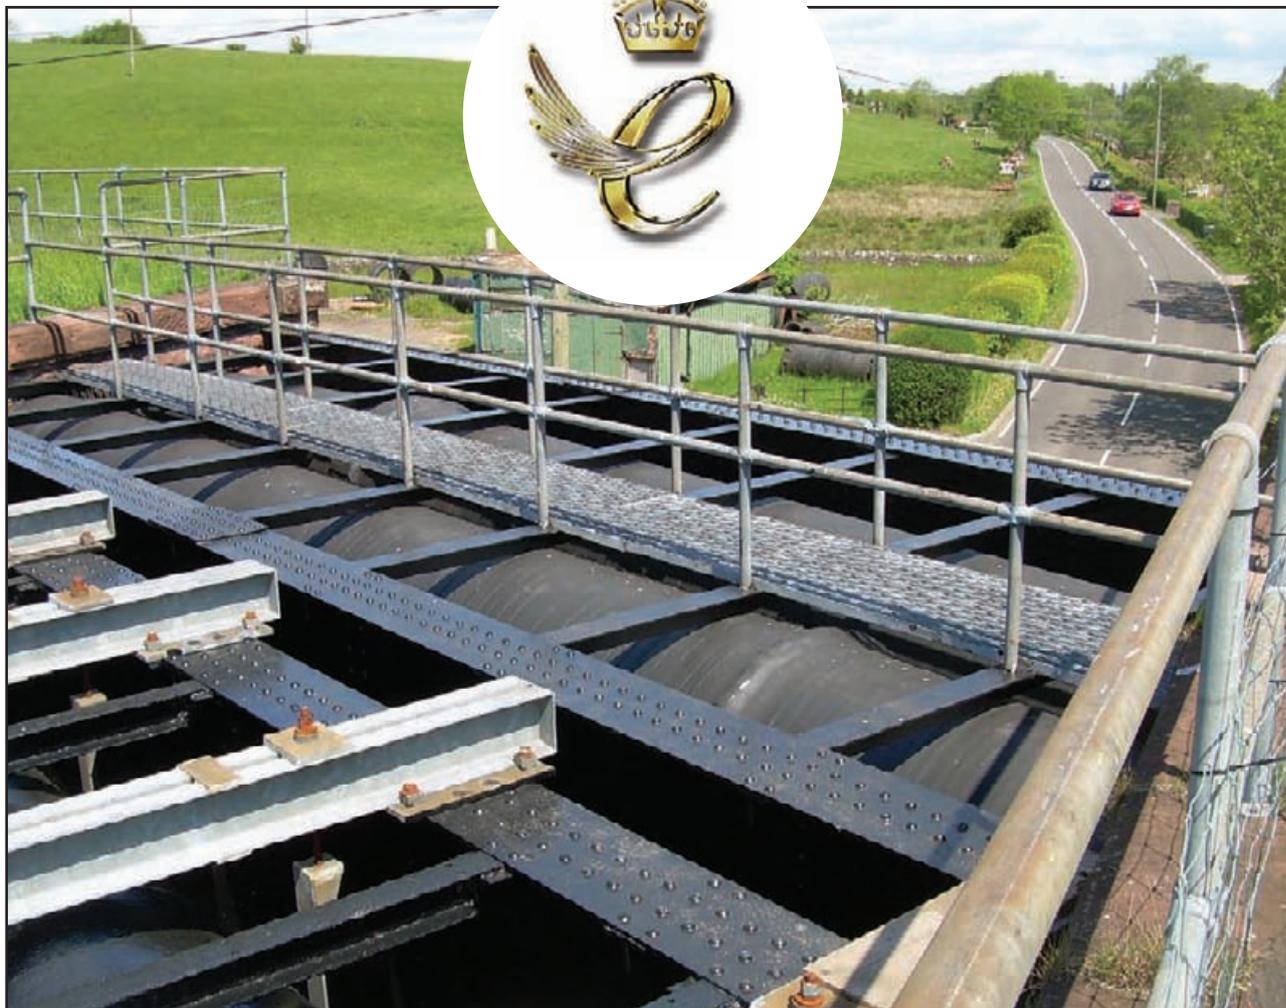
Aqueduct protected with the Denso Steelcoat 400 System, Loch Katrine Scotland - see page 11,

The Denso Steelcoat 400 System was chosen to give long-life protection to the 48" diameter pipes used at three structures which were virtually reconstructed along the aqueduct system. These carry two twin pipeline sections conveying 450 million litres of water per day to 1.3 million people.

Subcontractor Interserve carried out the Denso Steelcoat application comprising a coat of Denso Hi-Tack Primer followed by Denso Hi-Tack Tape overwrapped with Denso Ultraseal Tape. The system was completed with a coat of Denso Acrylic Topcoat.

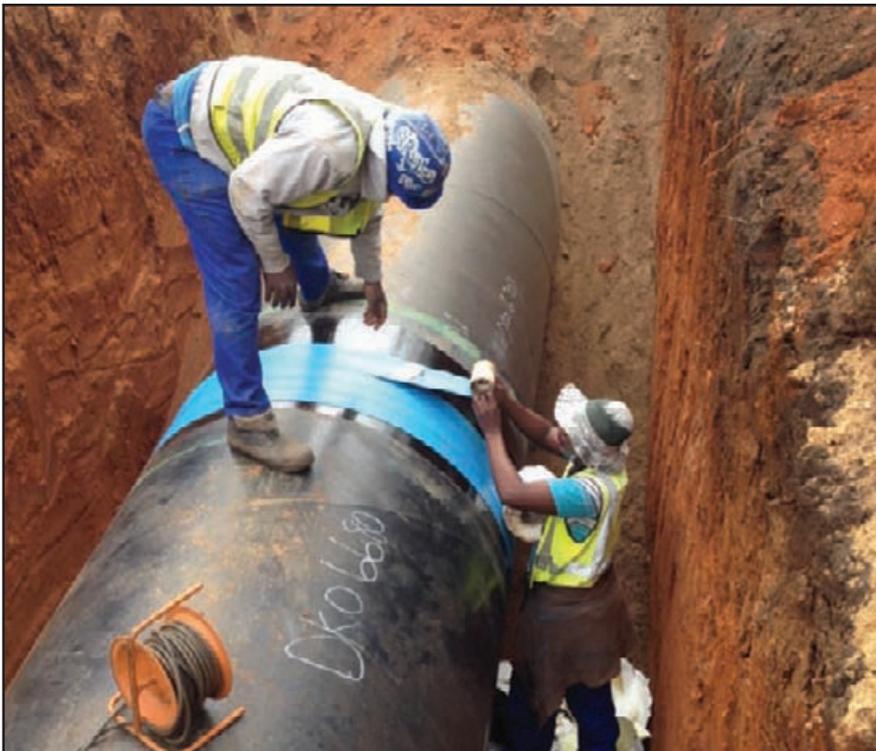
After application of Denso Primer D the joints are overwrapped with Denso Ultraflex 1250 Tape.

The Denso Weldbead and Ultraflex 1250 Tape is being used to protect the external welded joint. A mechanical clean to ST2 is required before the application of Denso Primer D, Denso Weldbead Tape and the Denso Ultraflex 1250 Tape.

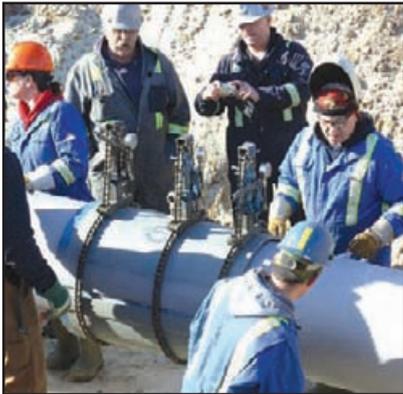
Fig 1. installation of a steel sleeve.

After non-destructive testing or NDE is performed on the exposed sections of the pipe where it has been identified to have been compromised, a steel sleeve is installed on the pipeline (see figure 1), recoated with the Denso coatings (see figure 2) and ultimately buried again. The Protal 7125 is applied to the entire bare steel surface and the Interface

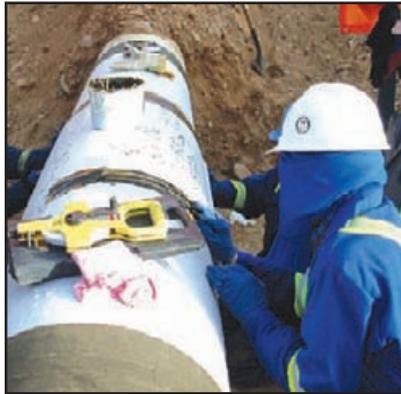
Fig 2. The Denso coatings are applied.

Denso Protal 7125 and the Denso Interface Coating System are widely used in pipeline maintenance because these products can essentially be applied to cold pipe, down to minus 20 Celsius for the 7125 and potentially colder for the Interface Coating System which is comprised of Denso Paste, Denso LT Tape, (possibly Denso Profiling Mastic) and Denso Glass Outerwrap.

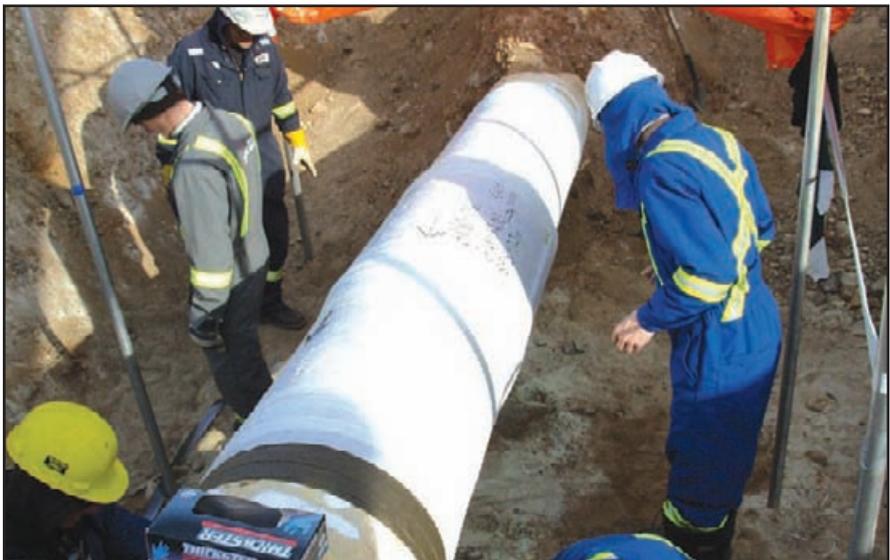
Fig 3. The repaired section is complete.

Coating ties the newly applied 7125 back into the existing line coating which in this case is PE (see figure 3).

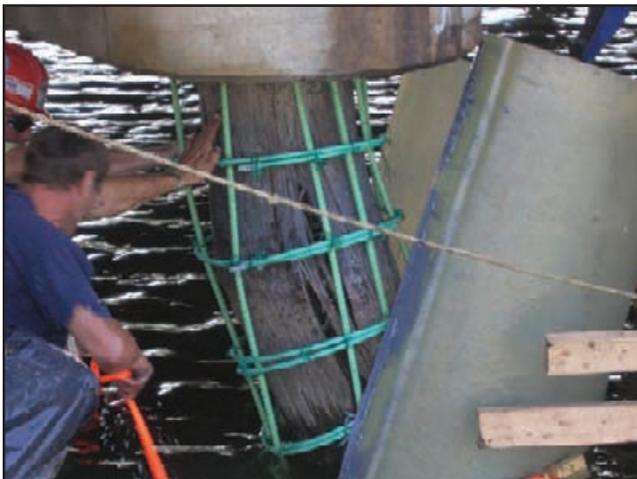
Rebar cage being fixed to the badly damaged pile.

The SeaShield Series 500 forms were taken by boat and barge out onto the river and affixed to specifically identified damaged piles. One of the piles was almost too badly crushed to affix the rebar cage and jacket around, but it was finally secured and pumped full of SeaShield 550 Epoxy Grout.

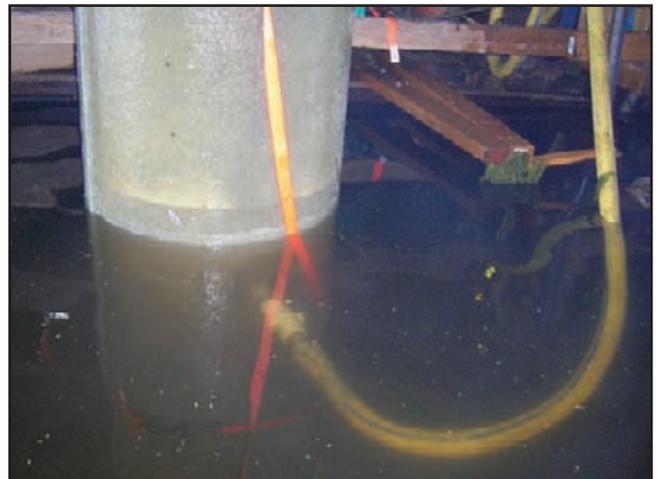
The SeaShield 550 Grout is pumped into the SeaShield 500 forms.

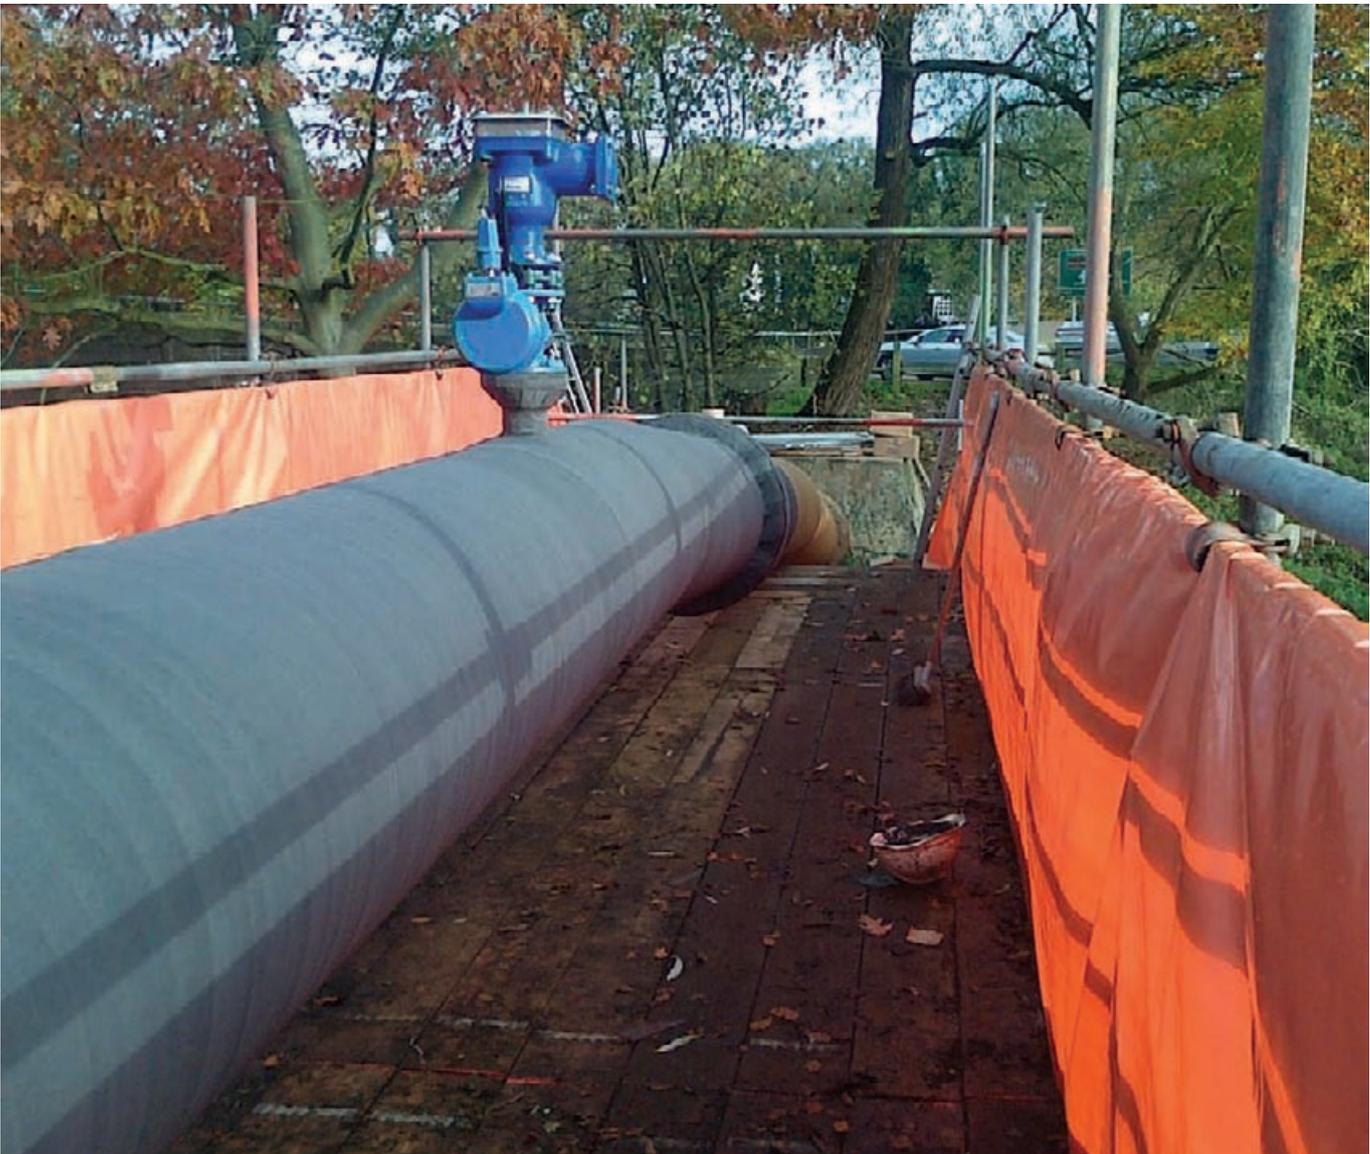
The Denso protected 30m pipebridge crossing the River Stour.

wire brushes and emery cloth, the 30 metre water pipe was protected with a combination of Denso Steelcoat 100 and 400 tape wrap systems. The structural steework supporting the pipebridge was protected with

the Steelcoat 700 System comprising two coats of Denso ST Epoxy followed by a coat of Denso Weathershield.

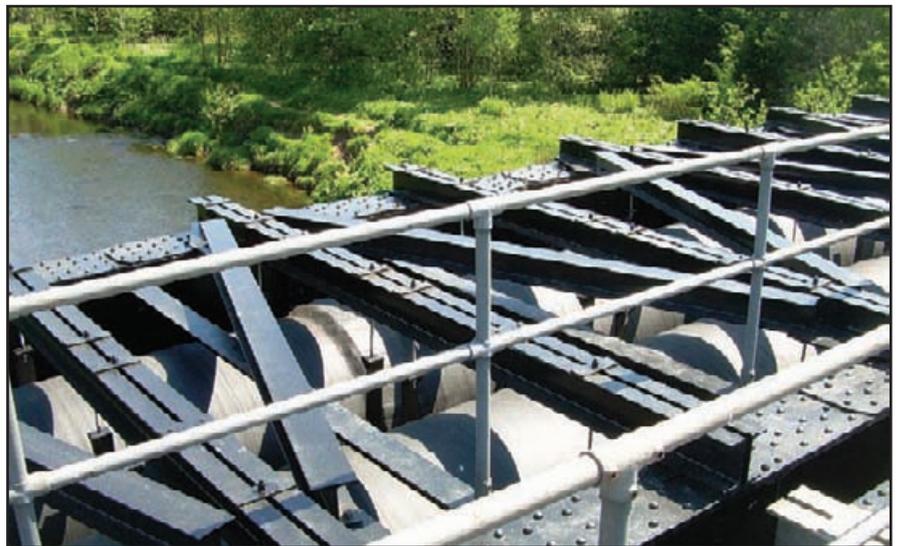
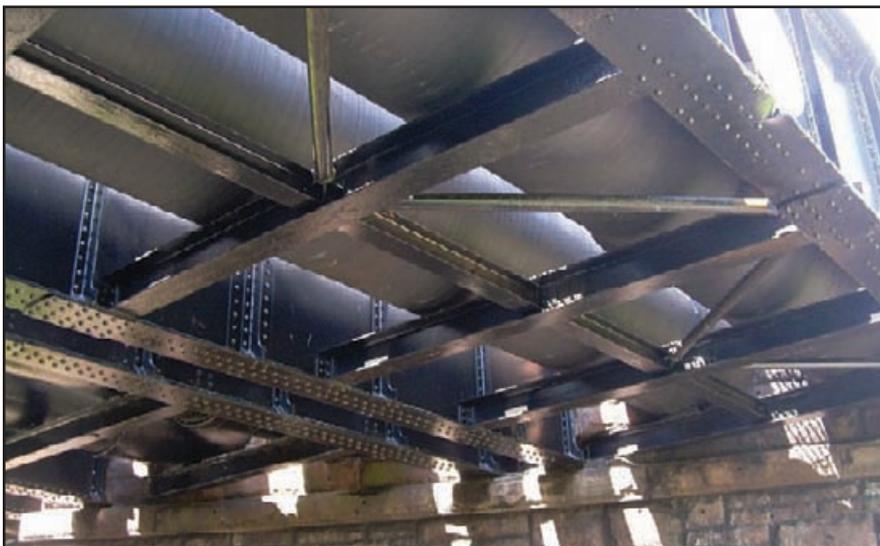
Photos:
Above and underneath view of one of the aqueducts.

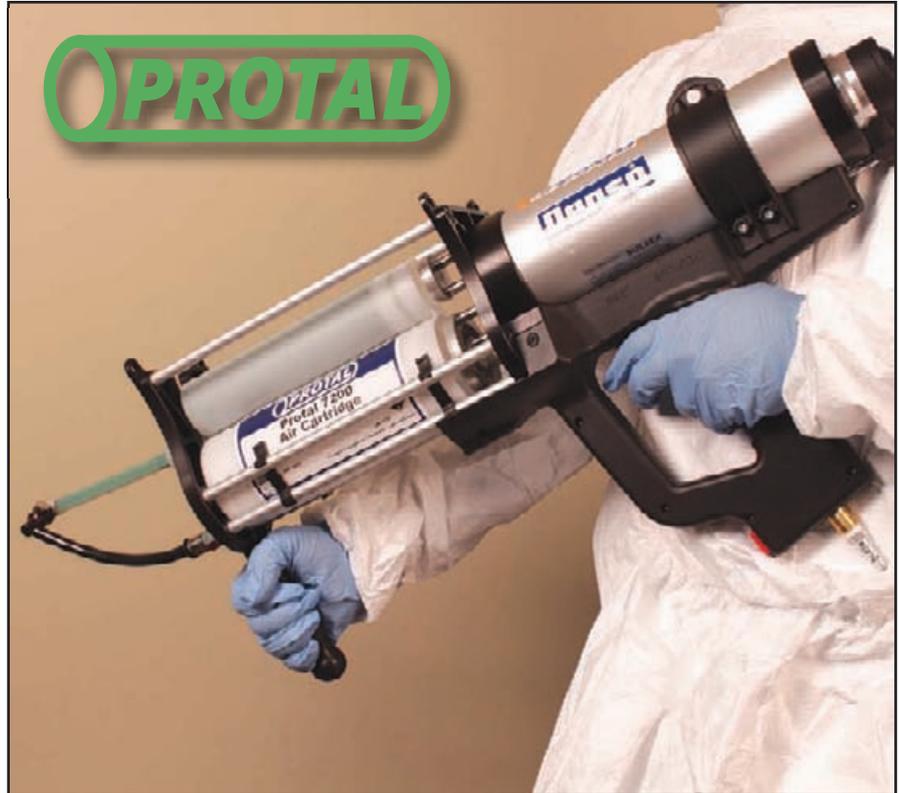
Above: The Protal 7200 Air Cartridge Gun.

The cartridge is then installed into the gun while connecting the quick-lock air coupling to the air mixing tip. The cartridge is purged slightly before proceeding with the spray application.

Each cartridge is spray applied in approximately 1 minute and will cover approximately 15 sq. ft at 25-30 mils.

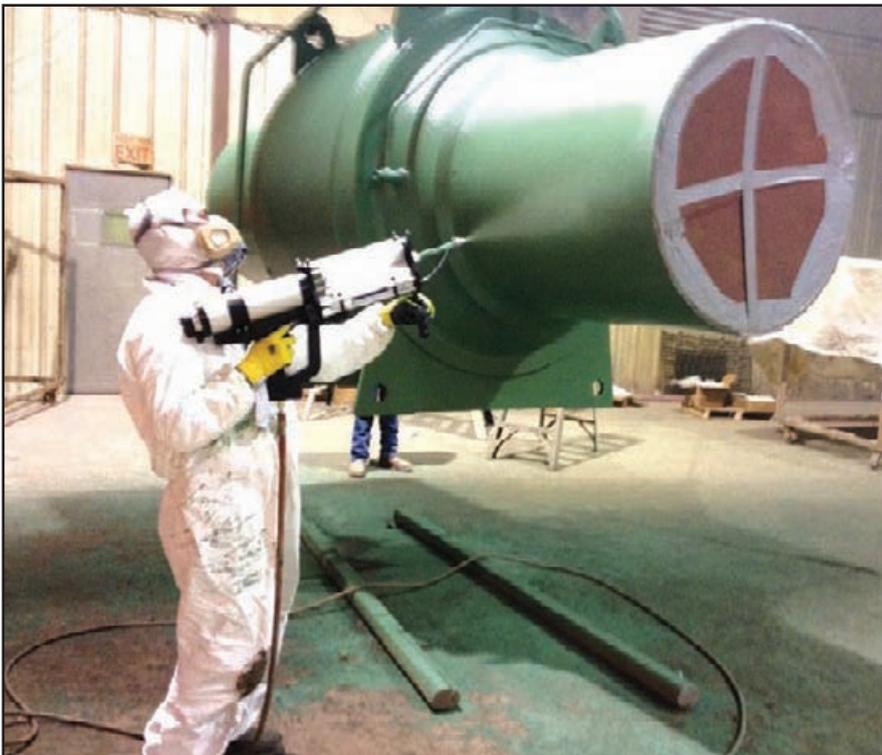
Left: Spray application of a 36" Ball Valve

First, the substrate to be coated was blasted to a near-white finish, SSPC-SP 10/NACE No. 2, while achieving a 2.5-5.0 mil anchor profile. The Protal 7200 Air Cartridge (1000ml) is heated in a 1000 watt microwave to approximately 120°F - 135°F (49°C - 57°C). Next the air mixing tip is tightened securely to the top of the air cartridge.

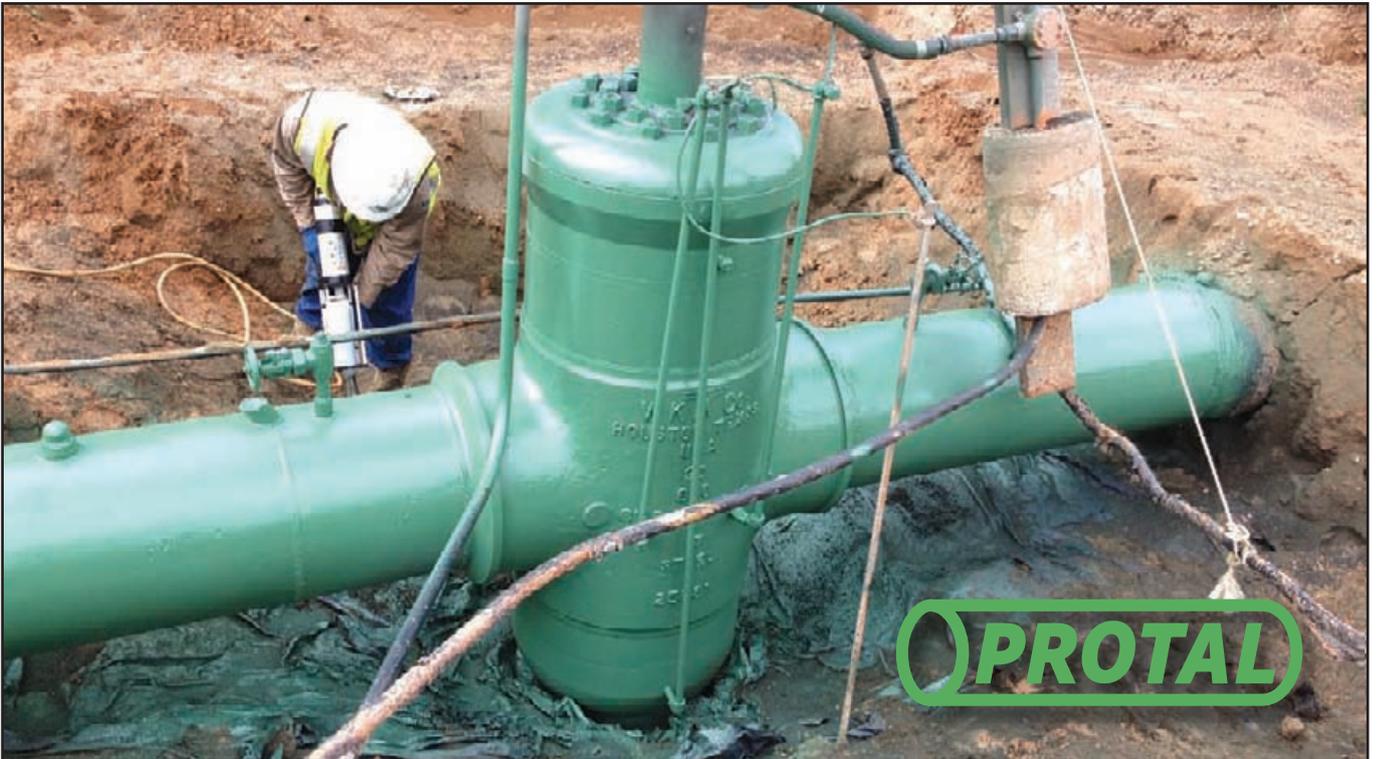
Above: Spray application of a 20" in service gate valve.

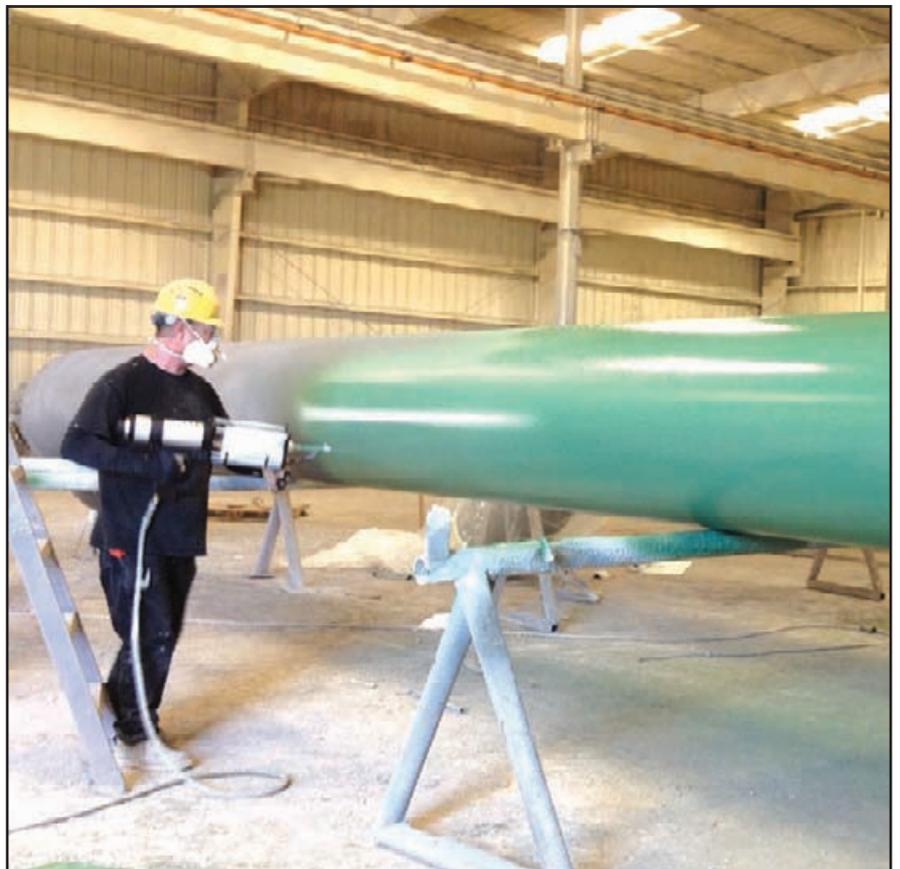
Right: Spray application of pipe.

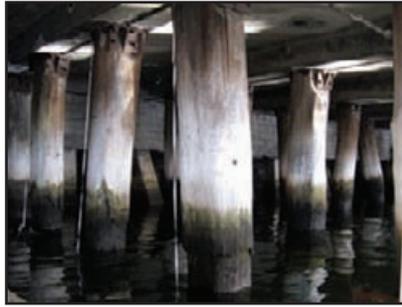
View of the timber piles beneath the dock.

The Denso SeaShield 400 & 70 Systems were the products of choice and specified by GHD for the rehabilitation of 1,200 timber piles ranging from 600mm diameter to 400mm in diameter. Protected pile lengths varied from 1.5 meters to 8 meters. The SeaShield materials used on this project comprised of 2,500 lineal meters of Denso fibre form jackets, 3,000sqm of Denso

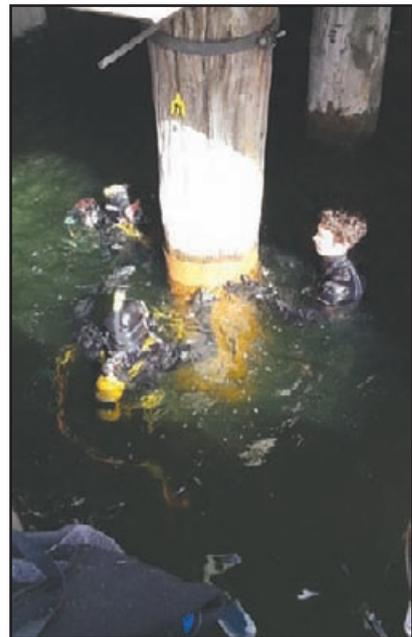
Above: Applicator of Denso Marine Piling Tape.

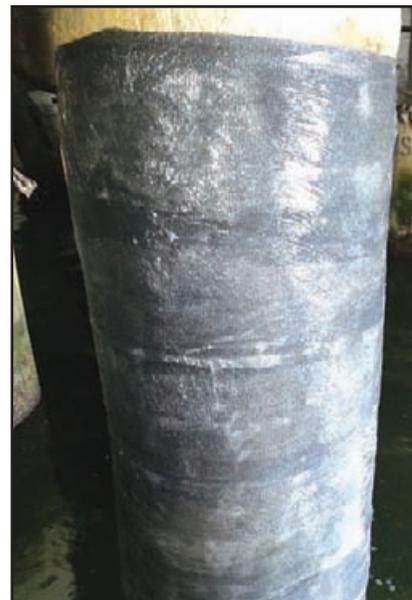
Below: The SeaShield 70 System is completed.

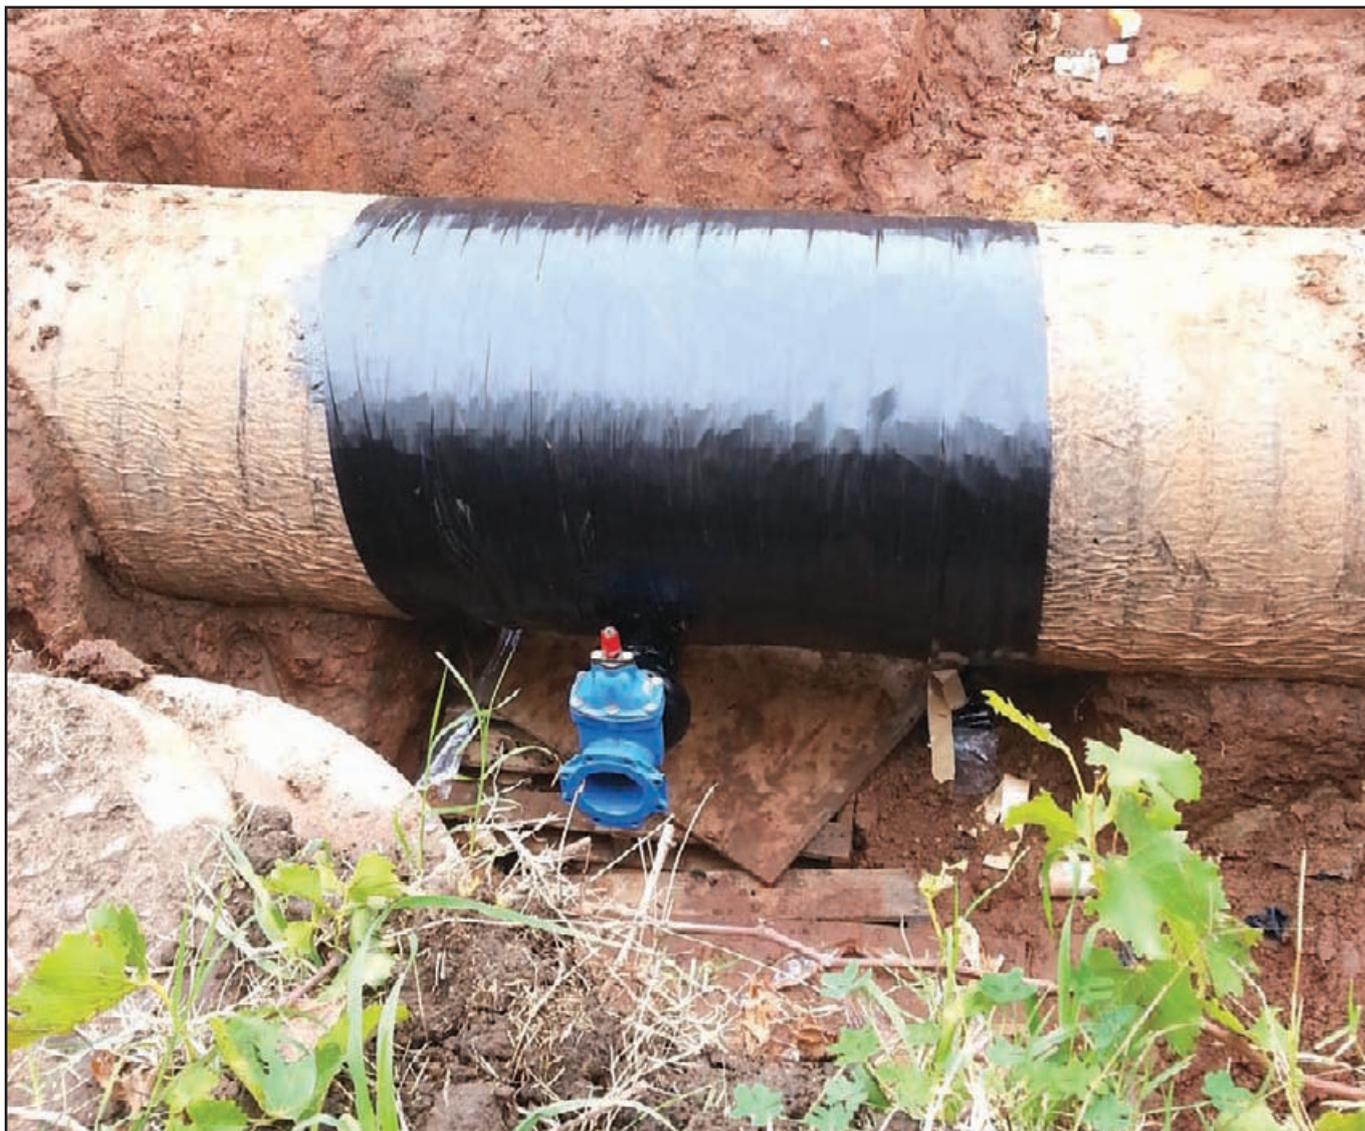
Densopol 60 Tape armoured with Denso PVC overwrap as per SA Water TS 81.

upgrade are Densopol 60 with PVC overwrap as per SA Water TS 81 for the main pipework and the Petrolatum system as per SA Water TS 29 for the flanges and new hydrant and risers.

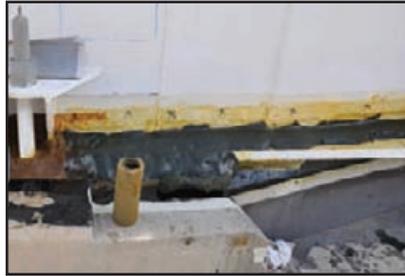
Applying the Denso Hi-Tack Primer.

Denso have developed an effective solution to this problem called the Denso Steelcoat Tank Base Protection System. The system seals the vulnerable area with a flexible but tough outer-armouring which is also highly weather resistant.

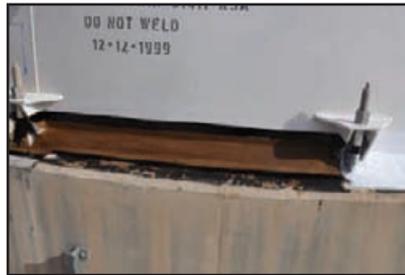
Applying Denso Primer D.

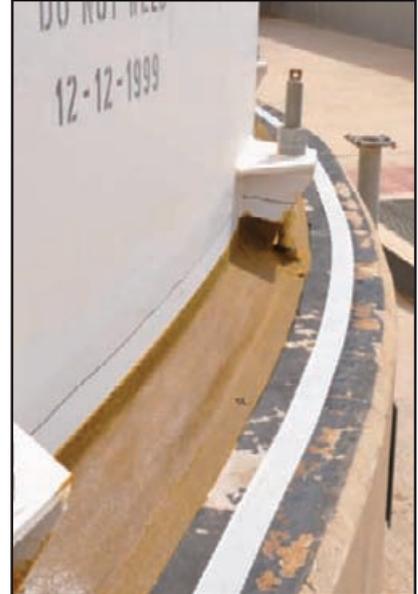
Applying the Denso Hi-Tack Tape.

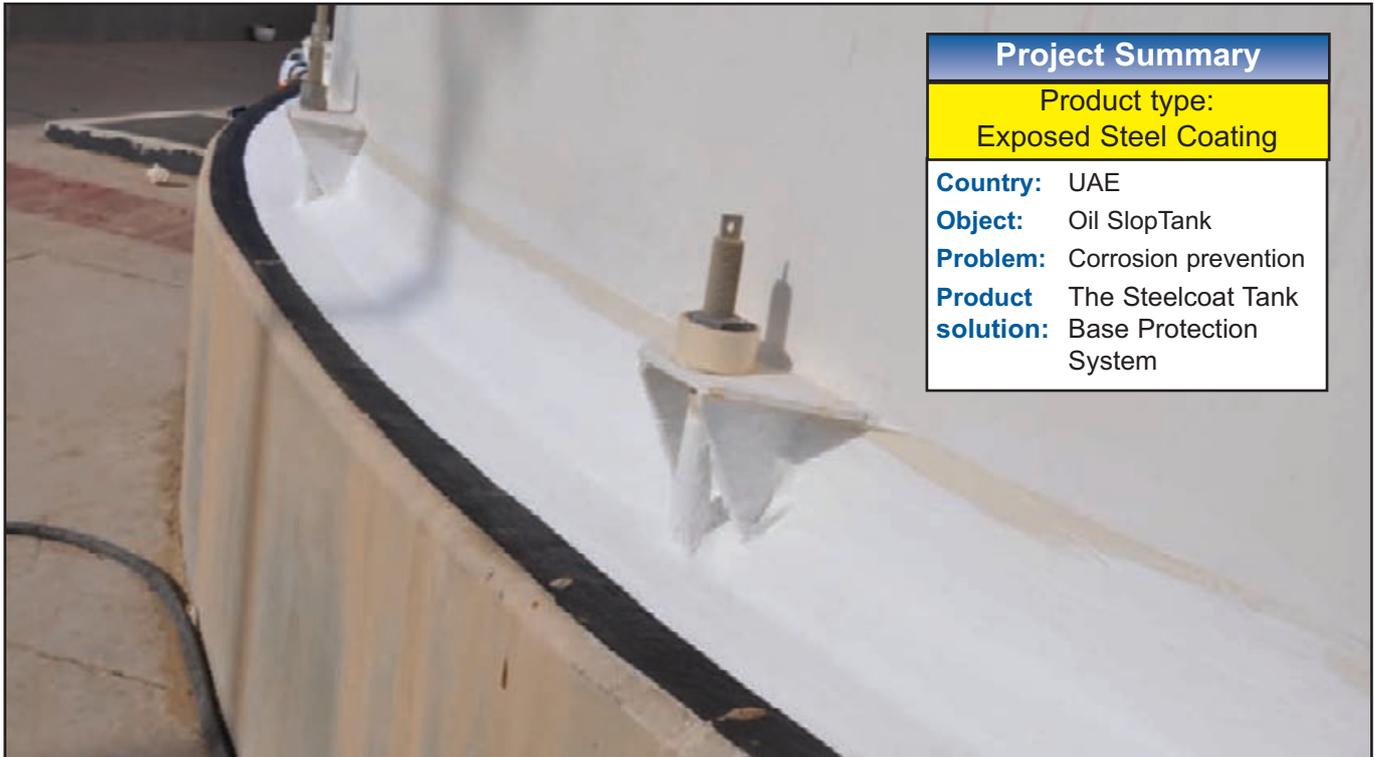
The completed Denso Steelcoat Tank Base Protection System.

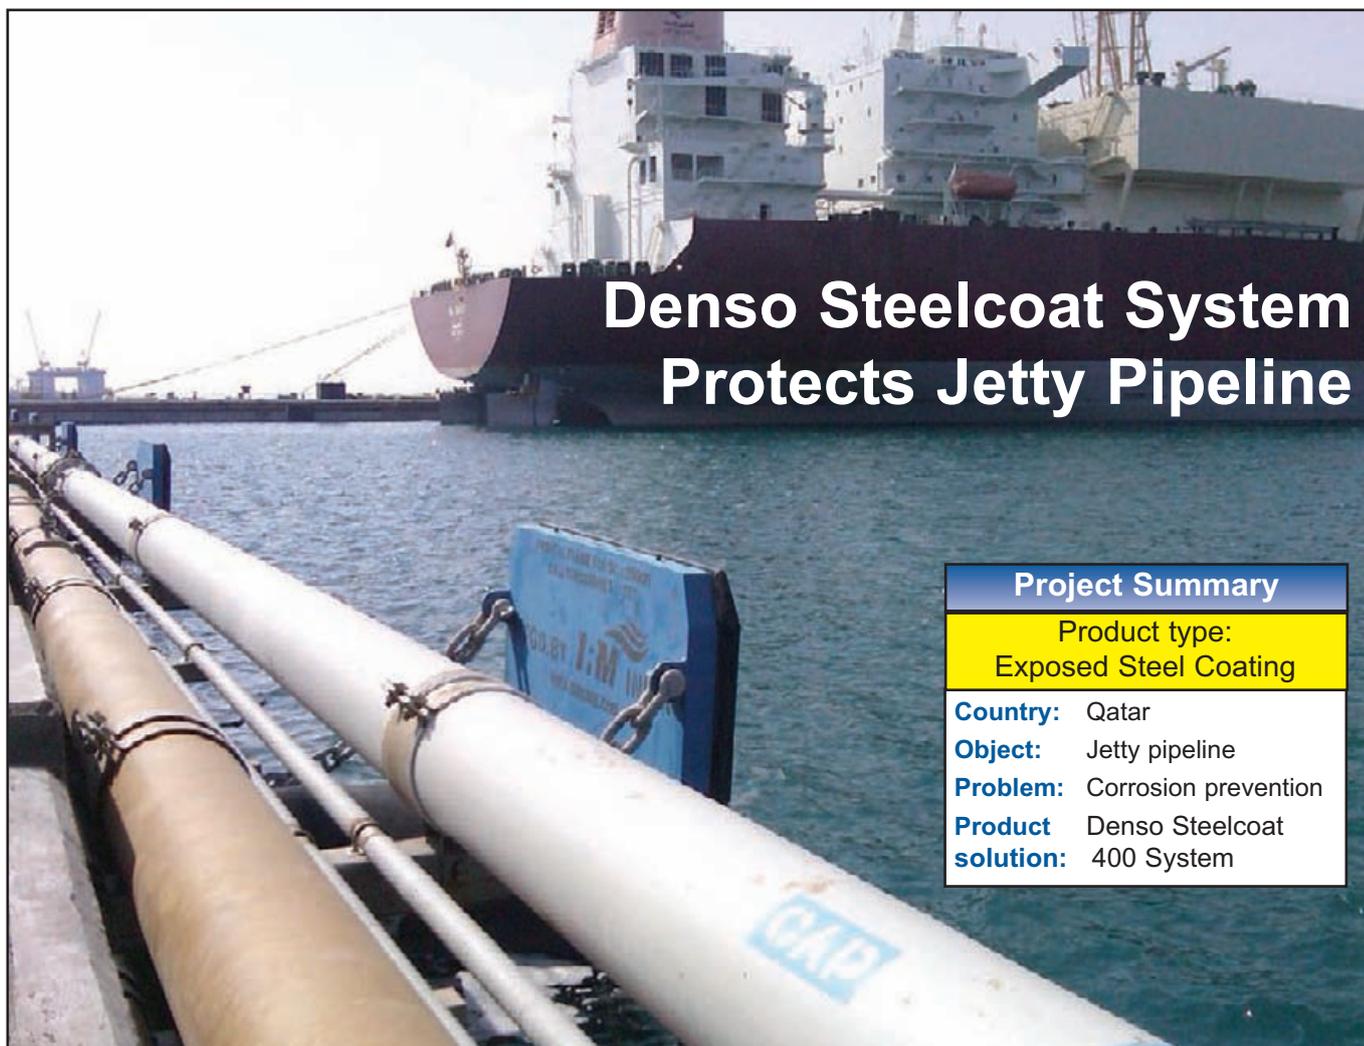
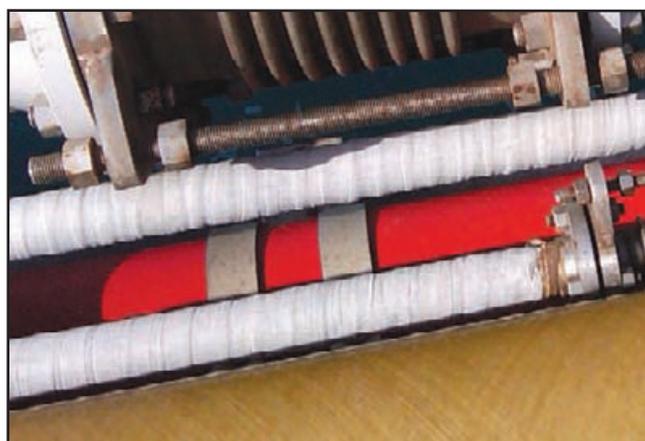
The pictures show different stages of the application of the Denso Steelcoat 400 System

The Denso Steelcoat 400 System designed especially for the elevated temperatures found in the Middle East was successfully utilised for the protection of 2 No. 2 inch diameter pipes 9km in length one carrying oxygen and the other acetylene located on the quay/pier in a Qatar Port as shown in the photos.

Due to the very harsh environmental conditions the project consultant decided that the best solution for the long-term protection of the pipes was the Denso system. The modified system comprises a coat of Denso Paste overwrapped with Densyl Tape with a 55% overlap. This was then followed with Denso Ultraseal RT Tape with a 55% overlap which was then coated with two coats of white Denso Acrylic Topcoat.

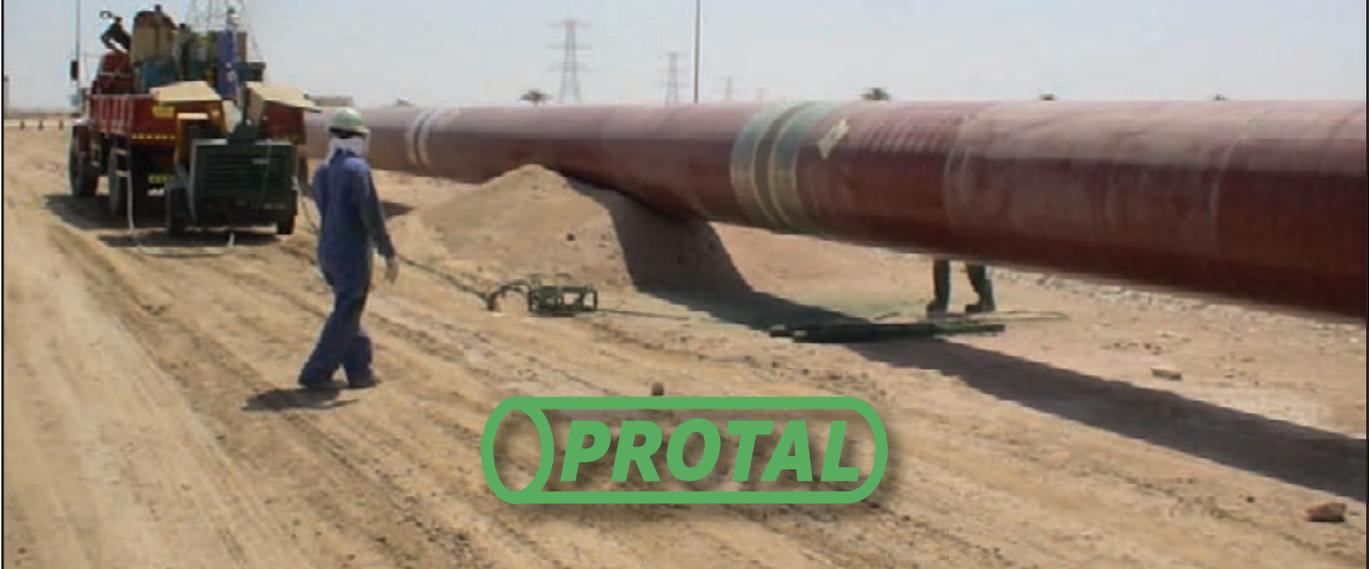
Above: The construction of the 48 inch diameter liquid fuel pipeline.

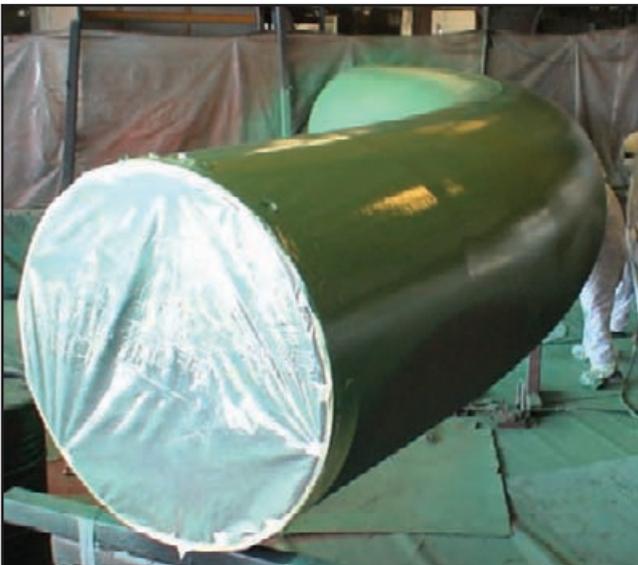
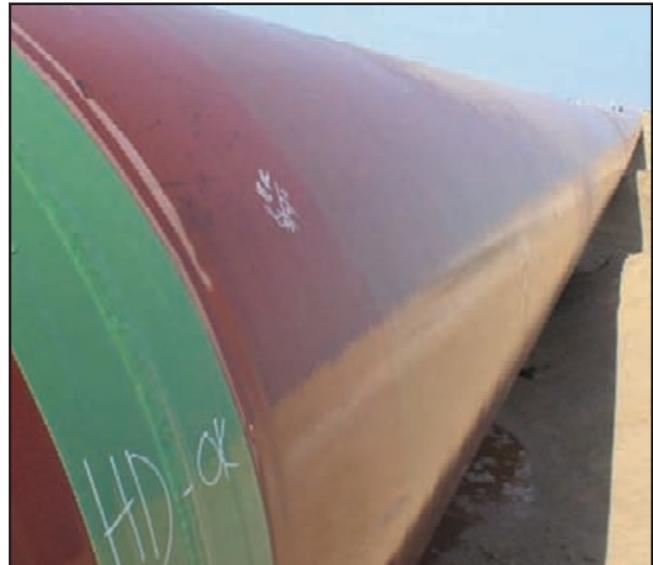
Below: Pipe bends and girth welds coated with Protal 7200

A.P.S. - Anticorrosion Protective Systems L.L.C. successfully applied the Denso Protal 7200 by Heated Plural Spray machine.

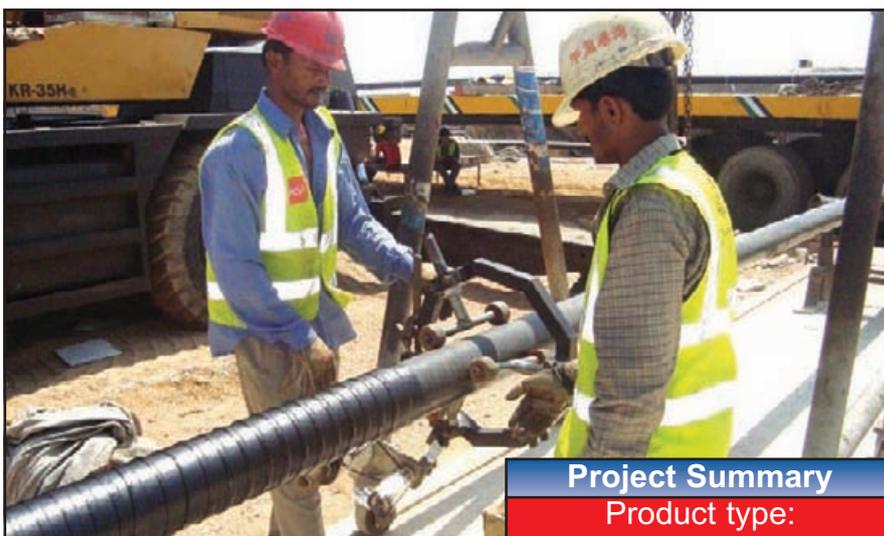
Machine wrapping the tie rods with DensoPol 60HT Tape.

This project called for a large quantity of Denso materials and the system specified comprised DensoPol 60HT Tape, with the large tie rod joints contoured with Densyl Mastic and overwrapped with Denso Self-Adhesive PVC Tape.

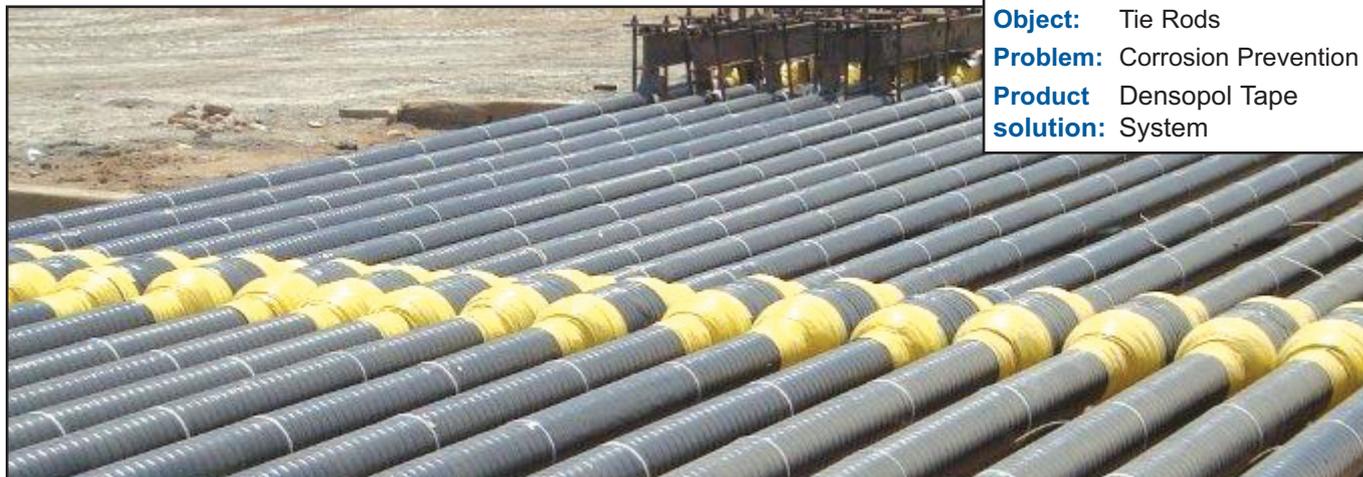
The Denso protected tie rods showing the articulated joints wrapped with yellow Denso Self-Adhesive PVC Tape.

As part of the tied bored pile quay wall design, the Denso protected tie rods were used to restrain a piled anchor beam that was positioned behind the quay wall. The anchor beam is supported by 1.6m diameter reinforced concrete piles, a design that has proven to have good earthquake resistance.
