# DENSO DIGEST

Volume 37, Number 4

# Cold Applied Viscotaq™ System Used to Protect a Water Main in Oman

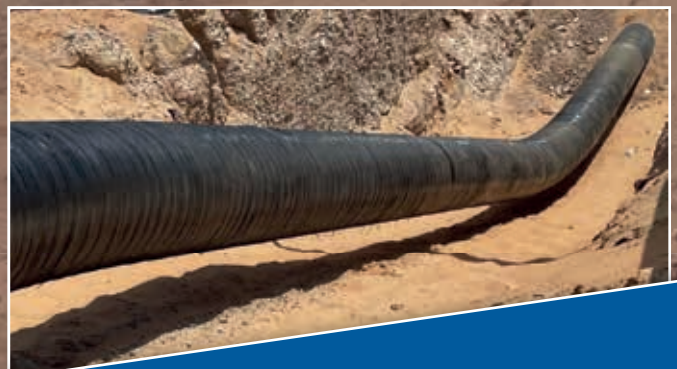
Below: The completed Viscowrap system with final layer of Denso Glass Outerwrap applied.

The Denso/Viscotaq system consists of an initial wrap of ViscoWrap HT™ Tape followed by a wrap of Viscotaq™ PE Outerwrap. Each layer was holiday tested in turn to make sure it was sound before a layer of Denso™ Glass Outerwrap was applied at the the soil/air interface sections to provide additional mechanical protection.

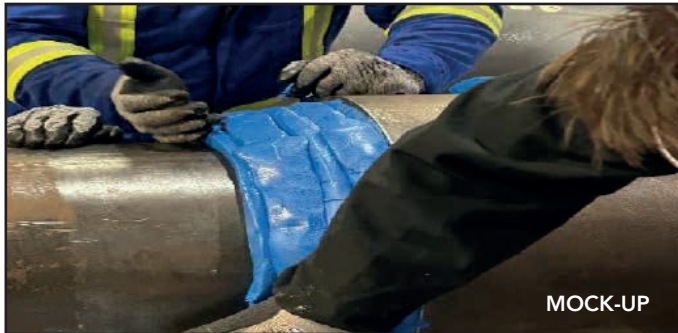
MOCK-UP

The Viscotaq Casing End Seal System was identified by a major Owner Groups' project team with information from the Denso team in Edmonton as the preferred choice for a chance at a permanent fix to the casing end seal. Maxx NA was approached as the applicator, and a request made to fabricate a scaled mock up of the casing. The mock up allowed for both training of Maxx personnel by Certified Denso Trainers with Viscotaq and a hydrotest to prove effectiveness. The typical parameter for this application is to be able to withstand a 5psi Hydrotest for a duration of 15 minutes. The process is highly involved with forces of the hydrotest being calculated with a complex formula to simulate natural forces that can occur with the casing pipe filling up with water. This is critical because the casing pipe will corrode very quickly if the area between the two pipes cannot be sealed and failure would be inevitable.

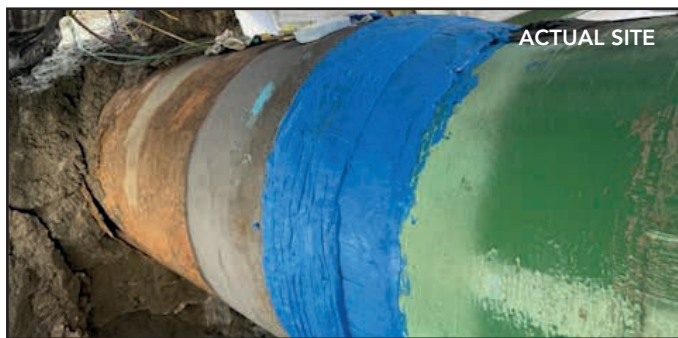
ACTUAL SITE

Above: The application of Viscosealant™ and Viscomastic™

The initial inside seal is done by pressing the Viscomastic™ uniformly and firmly into the annulus gap. It helps to heat the sticks in a microwave or rod box before installing to be more pliable. The unique situation here is that there is a larger 3-6" gap on the top of the pipe, but only ¾" – 1.5" on the bottom, it is off-centered. To ensure a better chance of success, we incorporated using Viscosealant™ with the Viscomastic on the bottom annulus gap to fill the smaller spaces. Once the Mastic was formed and shaped to allow a smooth transition for the Viscowrap™ ST, we proceeded to wrap circumferentially starting at the Casing pipe working down to the carrier pipe with sufficient tension and leading edge distances.

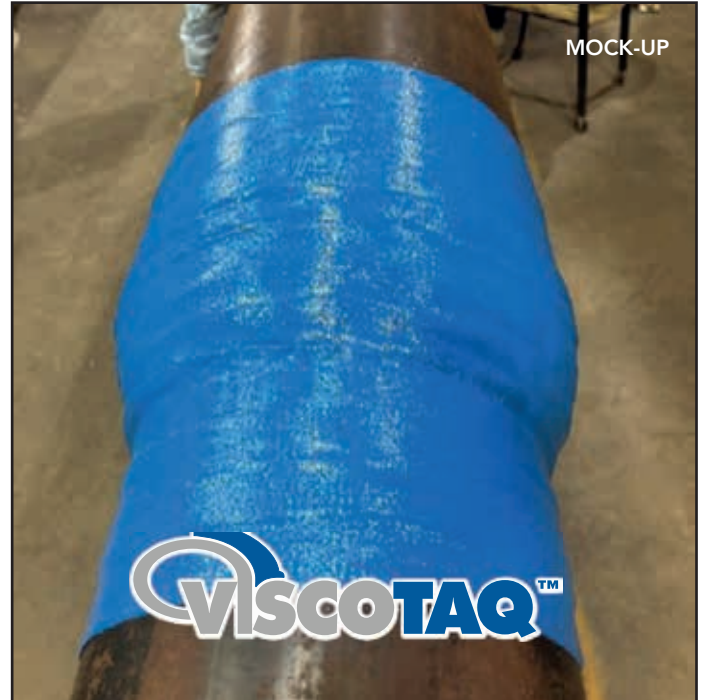
MOCK-UP

Above: The application of Viscowrap ST

Once the wrap is on tightly adhered, we proceeded to wrap Viscotaq™ Glass Outerwrap going in the opposite direction we did with the Viscowrap. Once complete with an overlap onto the pipe, we applied Polywrap to compress the Glass, then perforated the Polywrap to aid in curing. After about 30 minutes, we remove the Polywrap and continued to let cure for another 30 minutes. We would suggest a 2-3 hour cure for this process and an extra layer of Glass is also recommended. Now we are ready for hydrotesting.

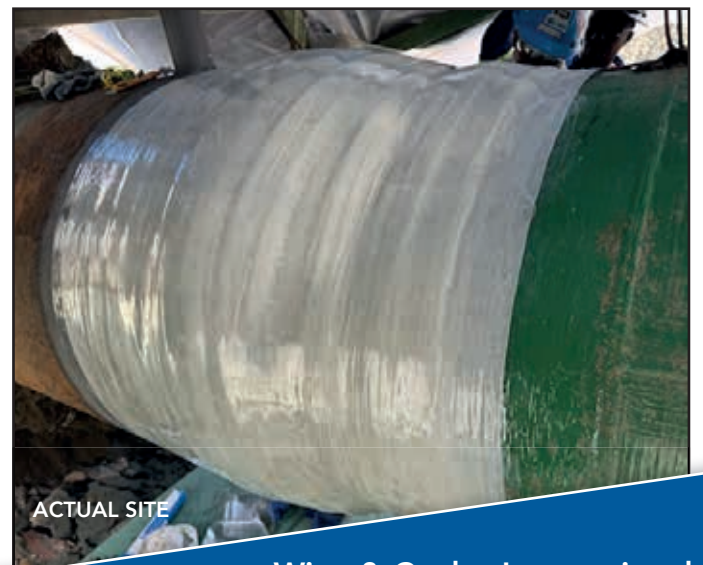
ACTUAL SITE

The final picture included below is from the actual site in Saskatchewan and the install looked great and should perform for many years for the company.

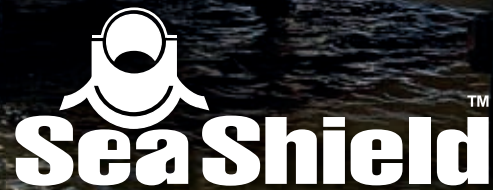
Denso was contacted by Brian Greene of GBI Diving for his customer, who was searching for a solution to prevent further degradation of the timber piles on their boat dock. The piles were still in relatively good condition; however, the homeowner wanted to proactively prevent further wear and tear from the salt water and marine borer damage.

Denso recommended the SeaShield Series 70™ Pile Protection System. The system is based around the Denso™ Marine Piling Tape, a petrolatum wax tape that truly seals off these timber piles from the destructive environment. The Denso Marine Piling Tape is protected by a layer of the Denso™ Glass Outerwrap UV, which provides a tough, durable, cast-like outer layer of mechanical and long-term UV protection.

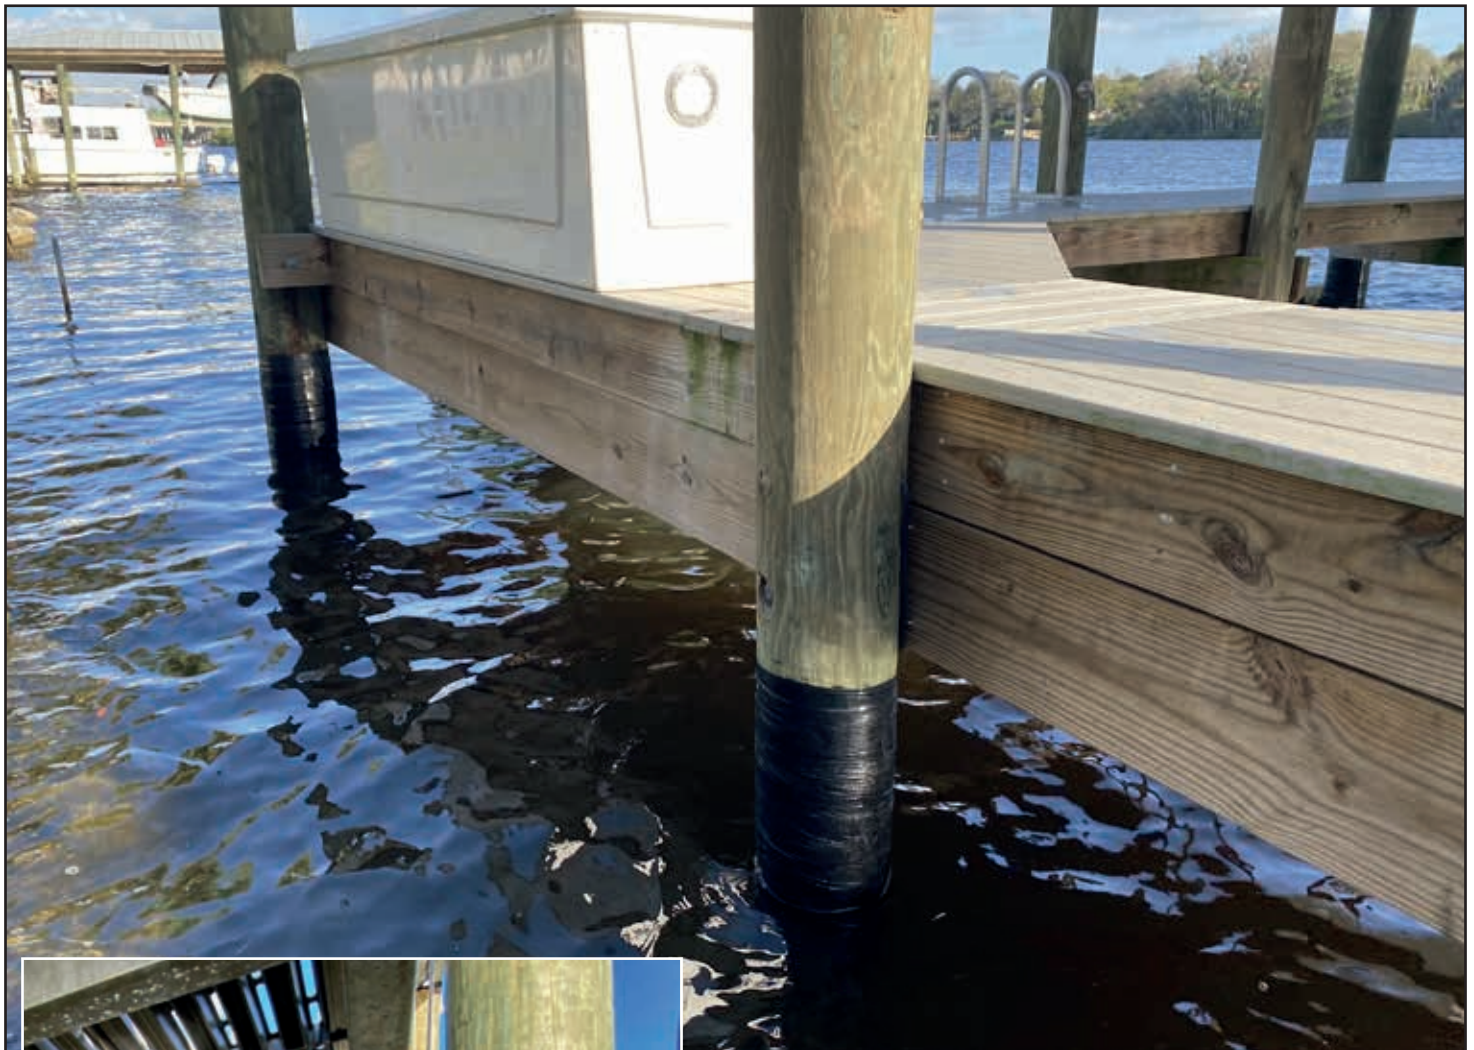
*Left: Long-term protection that adds years of service life to piles.*

*The SeaShield™ system prevents infestation of marine borers.*

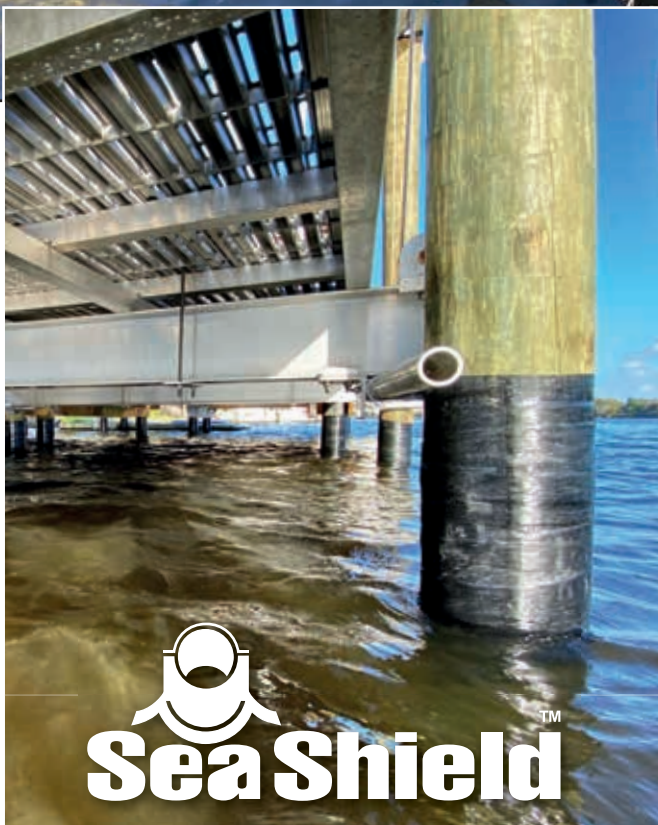
*Left: Simple design allows for easy installation.*

The system is extremely simple to apply and does not require any custom-made sizes. First, the Denso Marine Piling Tape is spirally wrapped around the pile using a 55% overlap, followed immediately by a layer of the Denso Glass Outerwrap UV that is also spirally wrapped using a 55% overlap. In addition, it helps to tightly wrap a layer of the Denso™ Poly-wrap over the Glass Outerwrap UV temporarily to help compress down the layers. The Poly-Wrap is removed once the Glass Outerwrap UV has cured after approximately 1-2 hours.

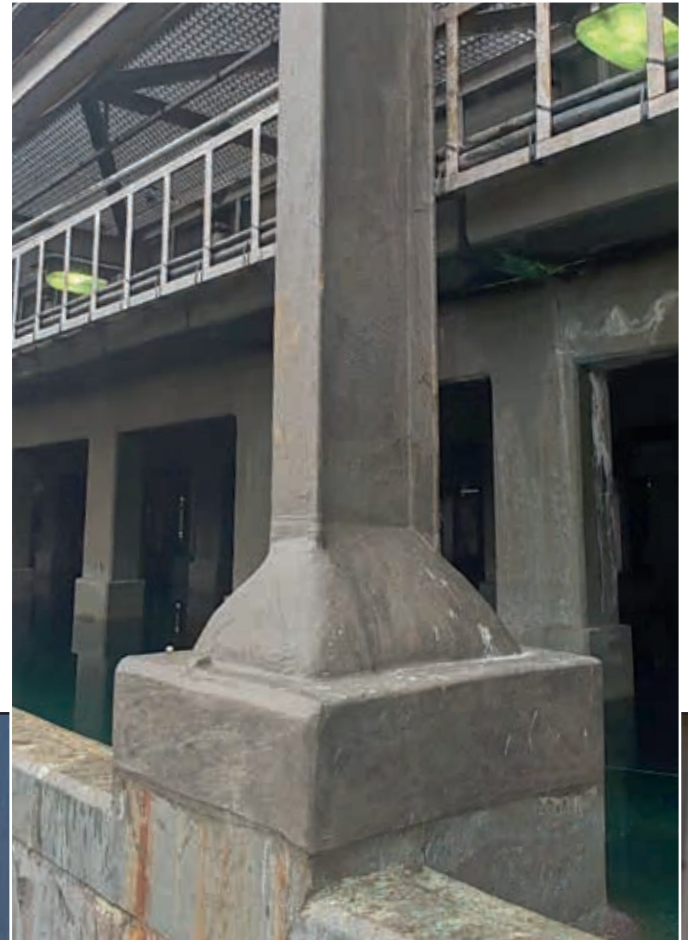
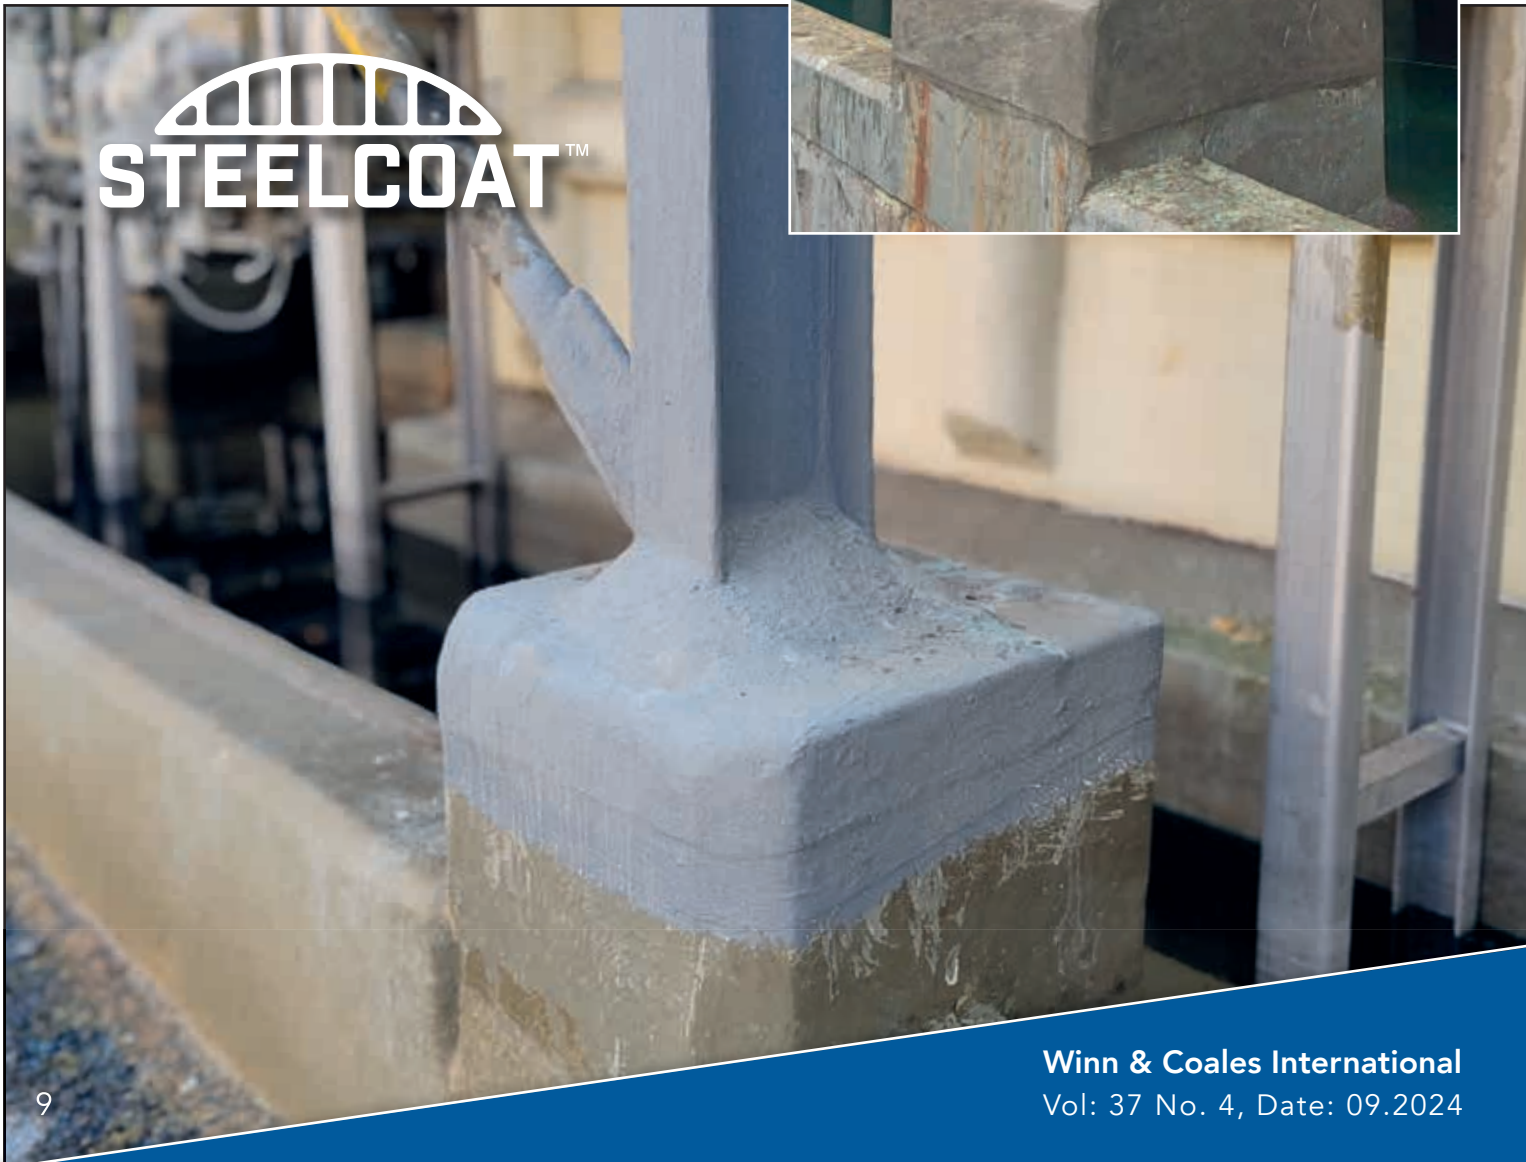
*Top right: The Steelcoat™ Column Base Protection System in place before the Denso™ Acrylic Topcoat is applied..*

*Below: Completed Steelcoat™ Column Base Protection System*

The Steelcoat™ Column Base Protection System was recommended. This system comprises of Denso™ Hi-Tack Primer to coat the cleaned substrate, Denso™ Profiling Mastic is used to fill any voids and to build up any angles required to create a smooth profile, a layer of Denso™ Hi-Tack Tape is then applied over the area followed by a layer of Denso D14™ Scrim and a coat of Denso™ Basecoat and Denso™ Acrylic Topcoat is applied to complete the protective system.

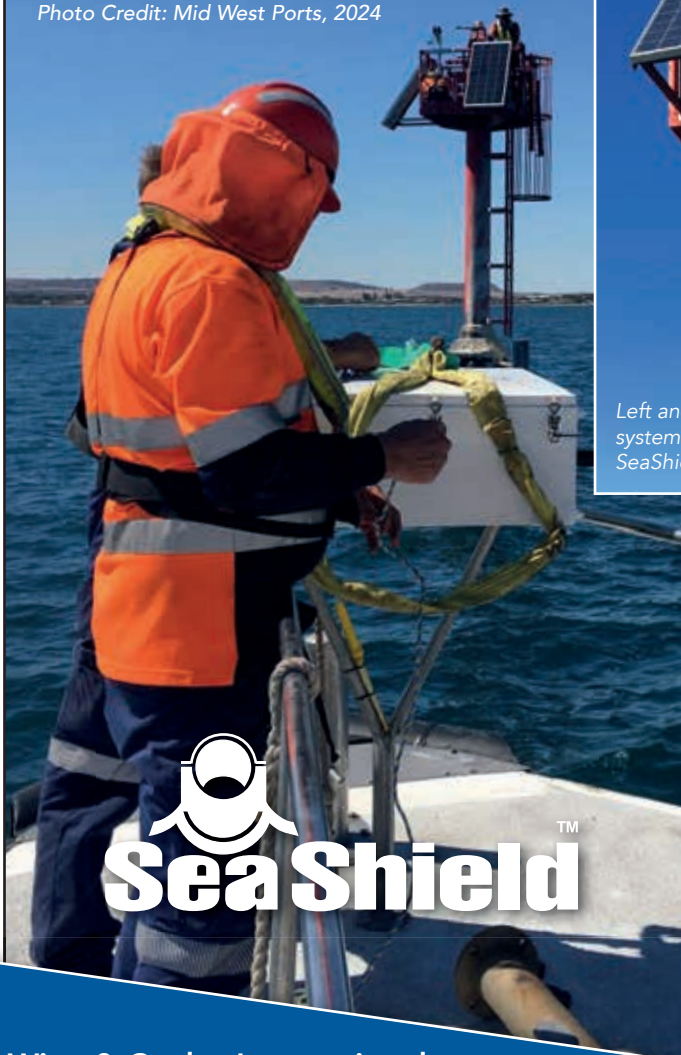
We take tremendous pride in regularly safeguarding critical assets all around the world. This is well evidenced in a recent example where Denso's SeaShield 70™ system was selected to provide long-term corrosion protection to eight important marker beacons highlighting the safe passage into the Port of Geraldton.

The application of the durable tape wrap system was originally completed in 2021 by TAMS Group.

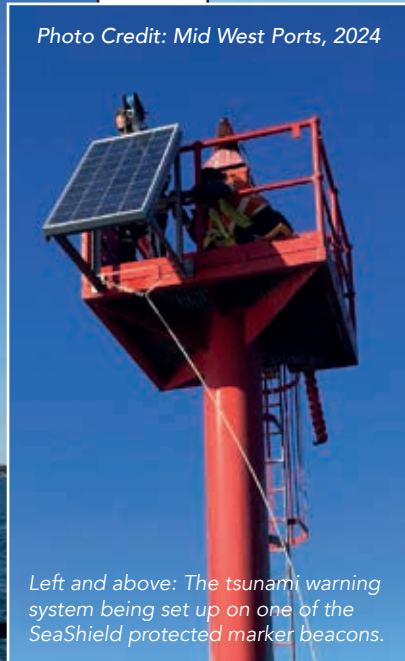
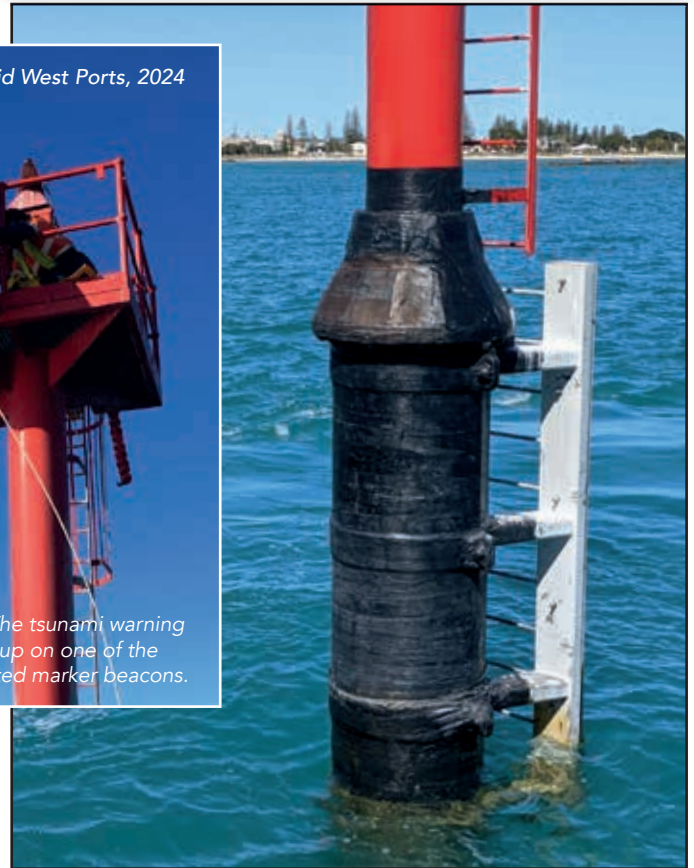
*Left and above: The tsunami warning system being set up on one of the SeaShield protected marker beacons.*

*Above: The completed SeaShield 70 system protecting the splash zone of one of the eight marker beacons.*

In June 2024, the marker beacon was equipped with a new Tsunami Warning System along the Geraldton coastline (an initiative undertaken by Mid West Ports, the Bureau of Meteorology and Geoscience Australia). These sensors are an Australia-wide initiative, providing real-time data to the Bureau of Metrology right across the country every minute. Recent photos of the installation show the SeaShield 70 system to be completely intact and maintaining its role in protecting the steel surface of the beacons.

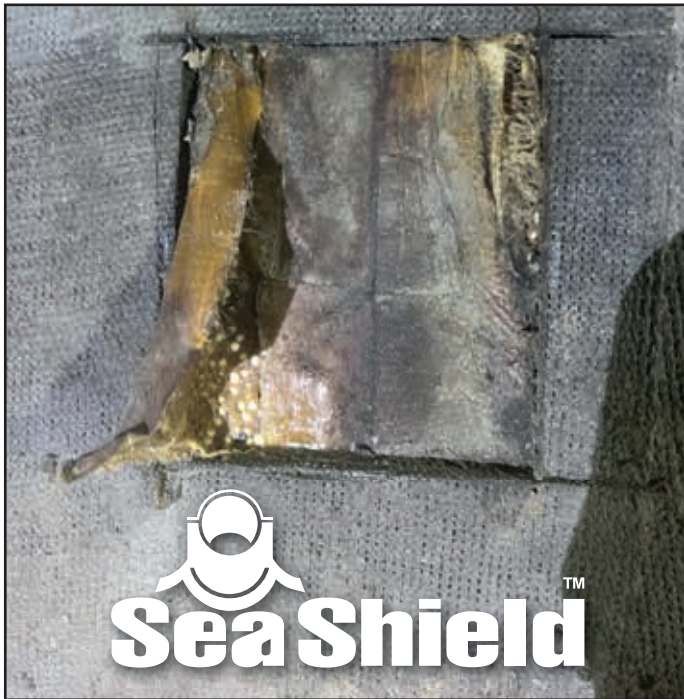
Above : A hole was cut in the 2015 applied coating and some of the Denso™ Profiling Mastic was removed to allow inspection of the inlet.

We've recently (July 2024) revisited the project site to check on the condition of the original coating. Upon cutting out a hole and removing the material, we are happy to confirm that no corrosion has occurred. The asset owner is similarly delighted with the result and have asked that we provide more product for the full completion of this project. The Denso team are adamant that long-term corrosion protection is best achieved through a combination of quality materials and quality application. As such, we'd like to credit the excellent work carried out by our contractor for this project, Swart and sons.

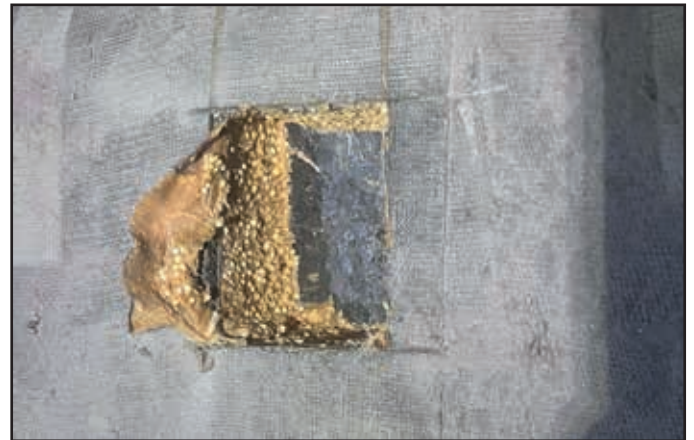
Once the inspection was complete and the inlet was found to be in good condition the Denso materials were replaced and the 2015 application was made good again.

In 2015, Denso Australia completed an application of its SeaShield 70™ system with the goal of providing long-term corrosion protection to the inlet at Murray Bridge's wastewater pump station (located in South Australia). The application of this system included the protection of waler beams attached to sheet piling. In addition to the components of the 70 system (SeaShield™ Primer, Marine Piling Tape, Denso™ Glass Outerwrap), Denso™ Profiling Mastic was also required to fill any voids and to contour around the sharp edges of the beams thus allowing us to achieve a secure spiral wrap around the asset.

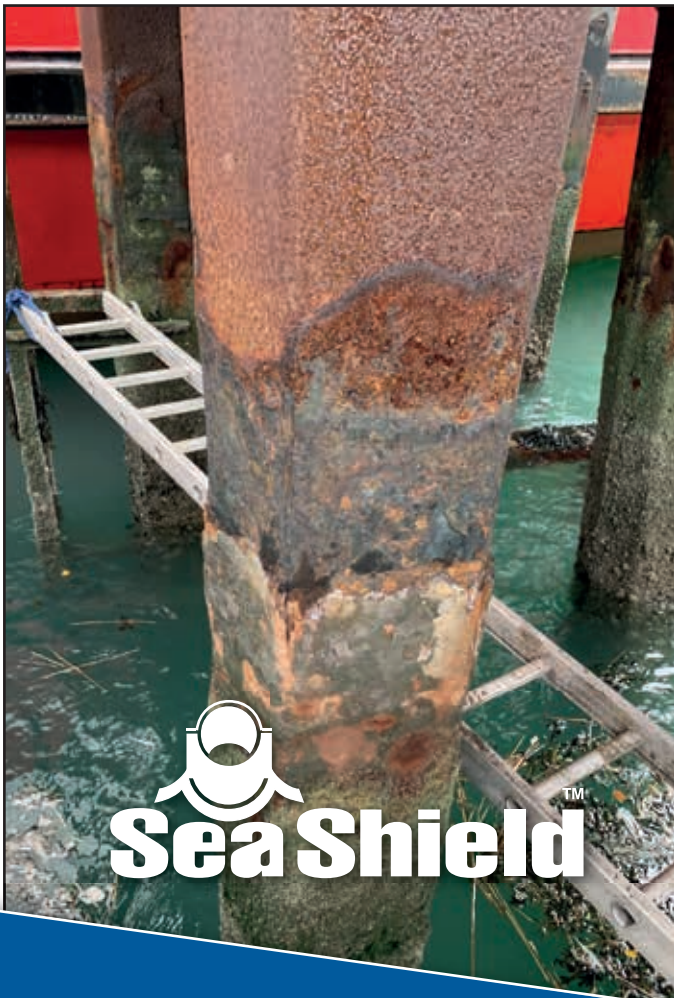
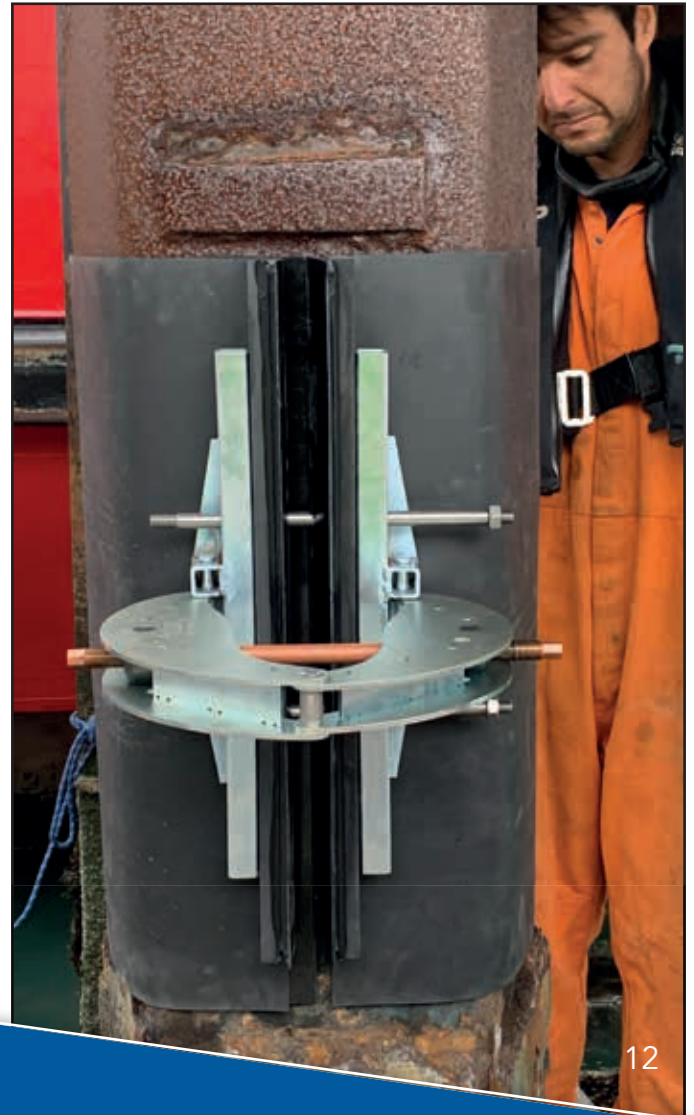
*Below: The condition of the pile (left) after cleaning and before the SeaShield™ HDPE Jacket is applied using the SeaShield™ Clamping Tool (right).*

Using a combination of the SeaShield 2000FD™ and SeaShield 70™ Systems, the piles were wrapped in the usual way on site (circumferentially), however some featured obstructions, such as ladder supports and O-rings which hold chains connected to the fenders. Thanks to the user-friendly application of Denso™ Glass Outerwrap UV (GOW UV) – a key component of the SeaShield 70 System – Seatech Commercial Diving Services were able to protect the areas where a typical HDPE jacket could not be applied. Both systems were then overlapped, leaving a fully protected pile from top to bottom.

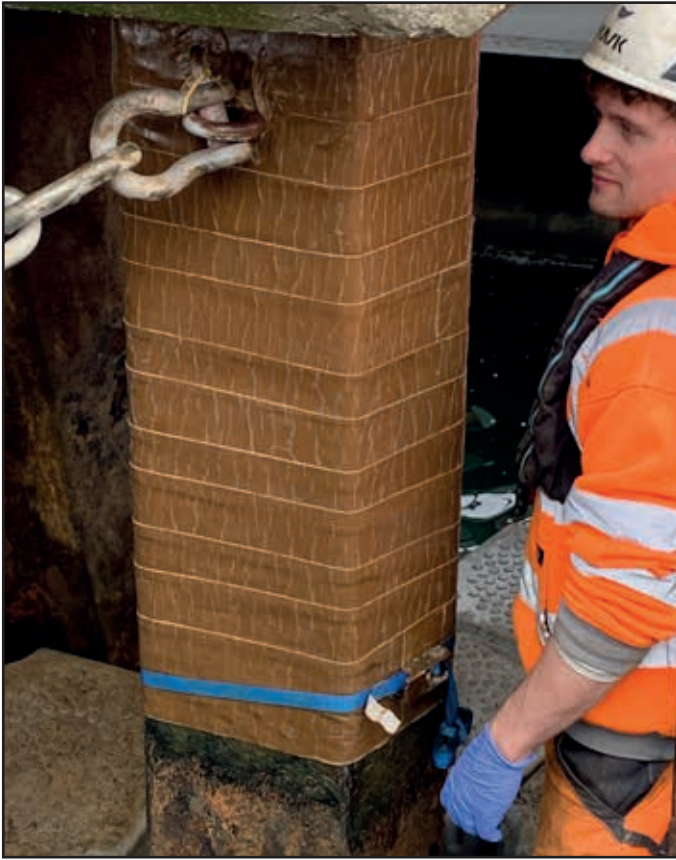
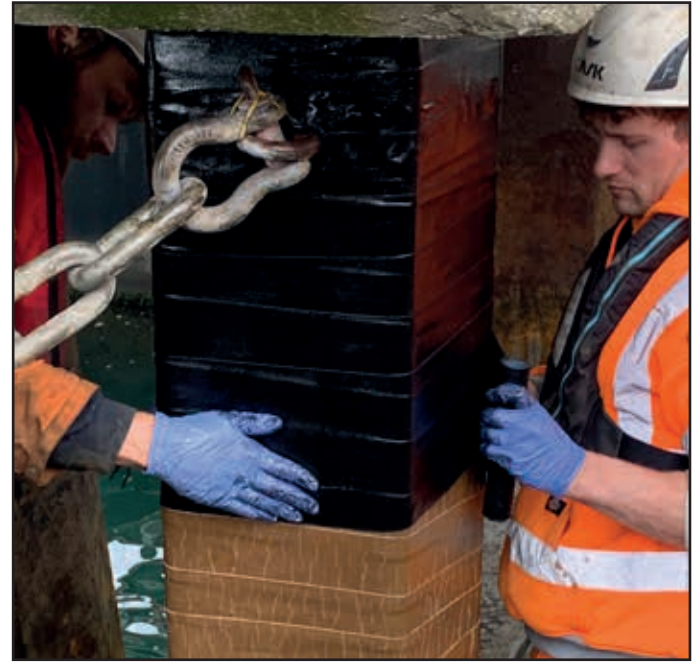
Above: A circumferential wrap of SeaShield™ Marine Piling Tape is applied to a pile (left) prior to applying the Denso™ GOW UV (right).

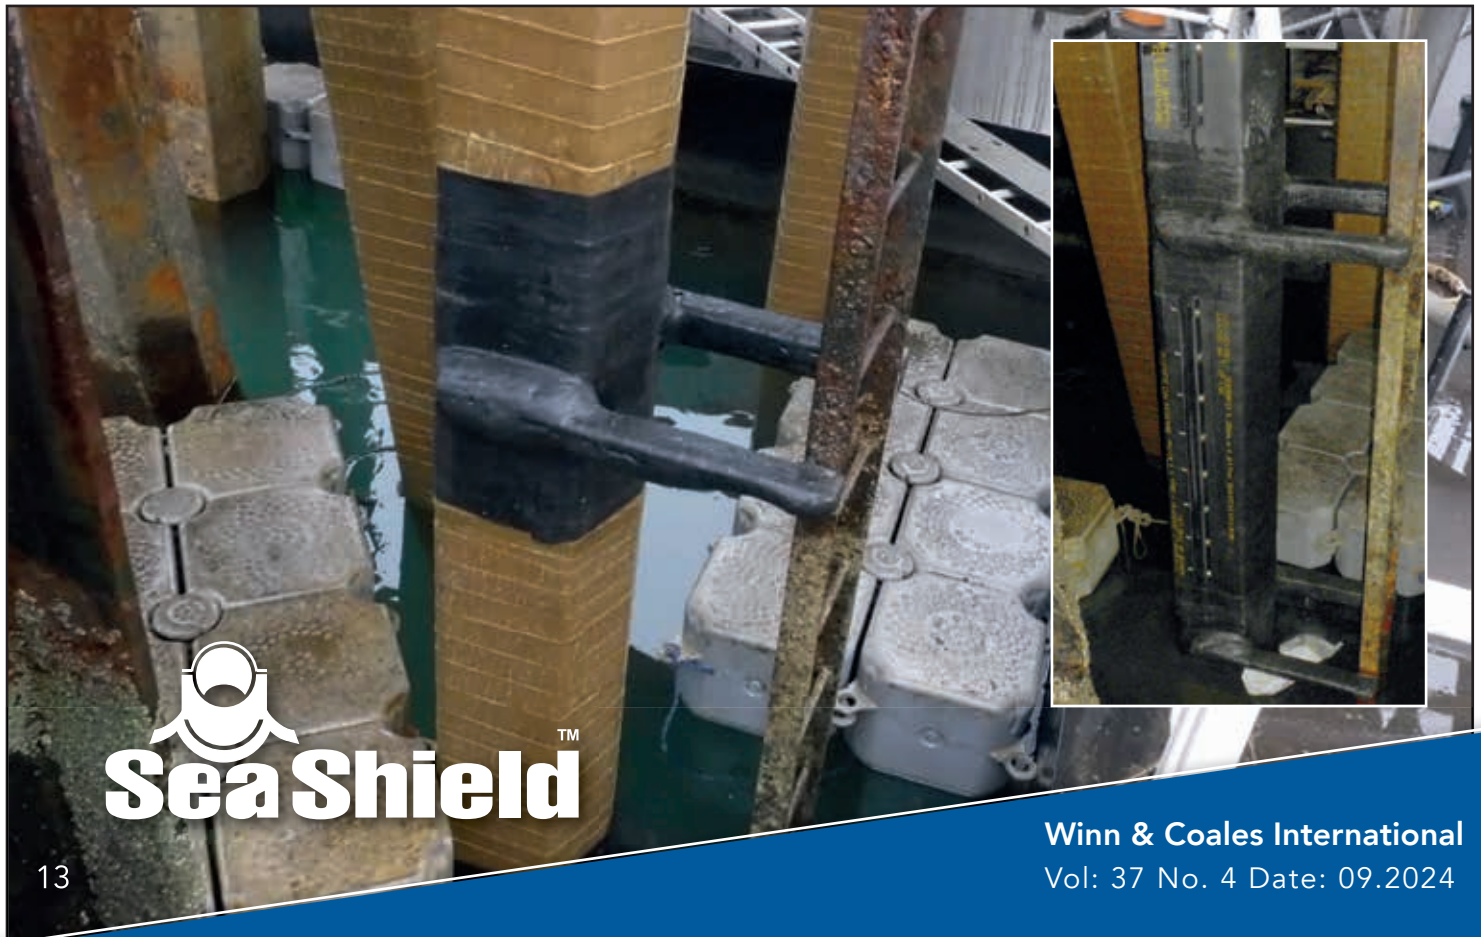
Below: Tape application complete and inset showing the completed combination of the SeaShield 2000FD™ and SeaShield 70™ Systems.

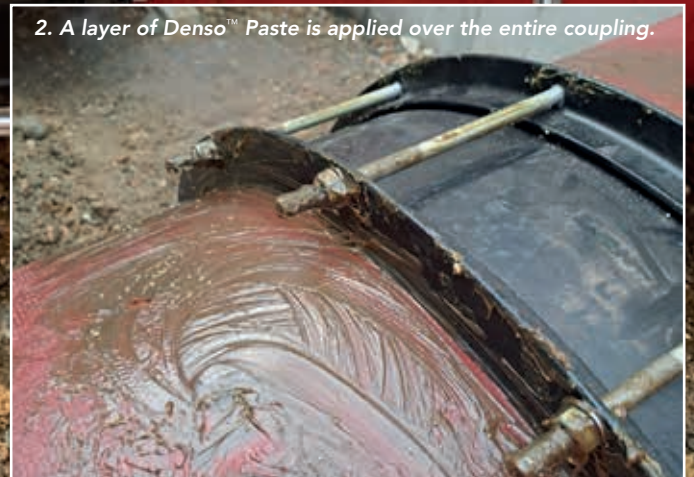
2. A layer of Denso™ Paste is applied over the entire coupling.

The fittings were primed with Denso Paste™, prior to the application of Denso™ Profiling Mastic to create an even profile and remove any trapped air or moisture. Denso Tape™ was then applied spirally with a 55% overlap to complete the system.

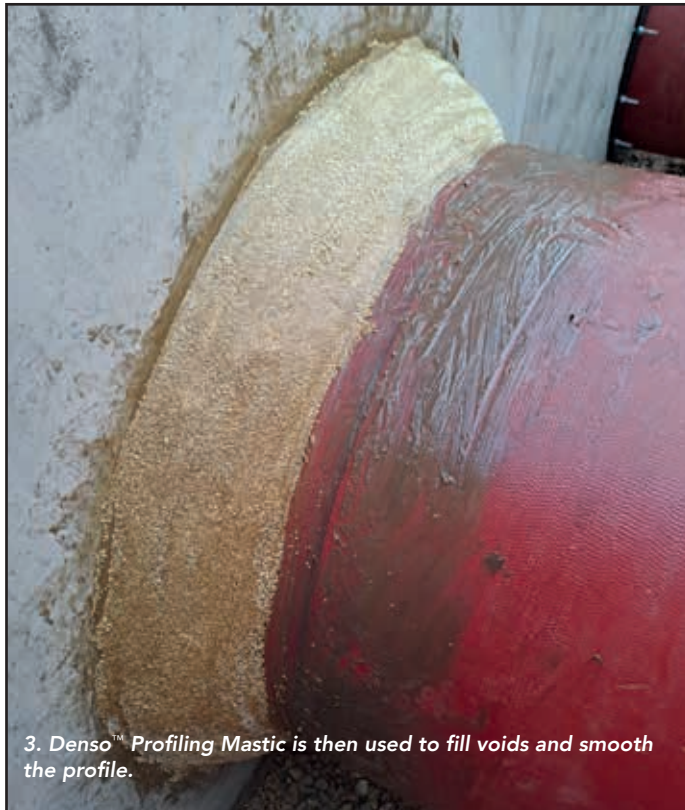
3. Denso™ Profiling Mastic is then used to fill voids and smooth the profile.

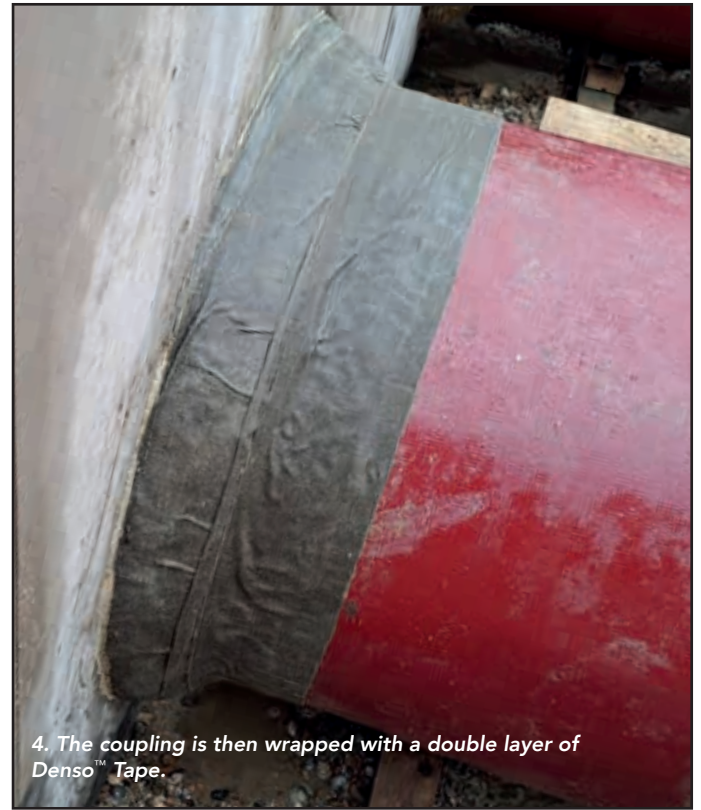
4. The coupling is then wrapped with a double layer of Denso™ Tape.

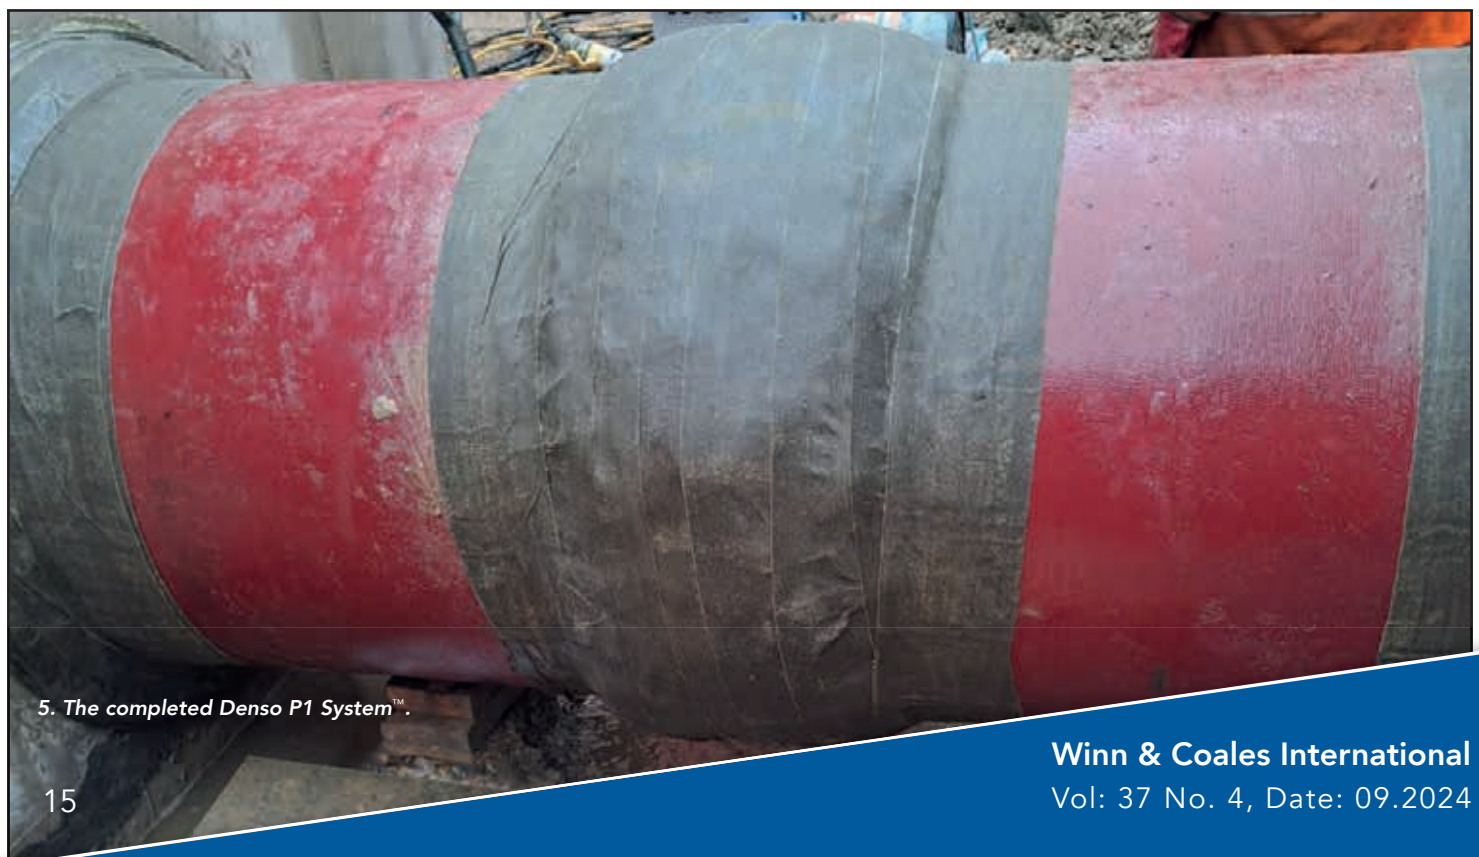
5. The completed Denso P1 System™.

The contractors followed the Instructions for Use documents and the CESWI P1 Specification for an excellent application, ensuring these assets are properly protected.
