Winn & Coales International Ltd.

# DENSO DIGEST

Volume 38, Number 2

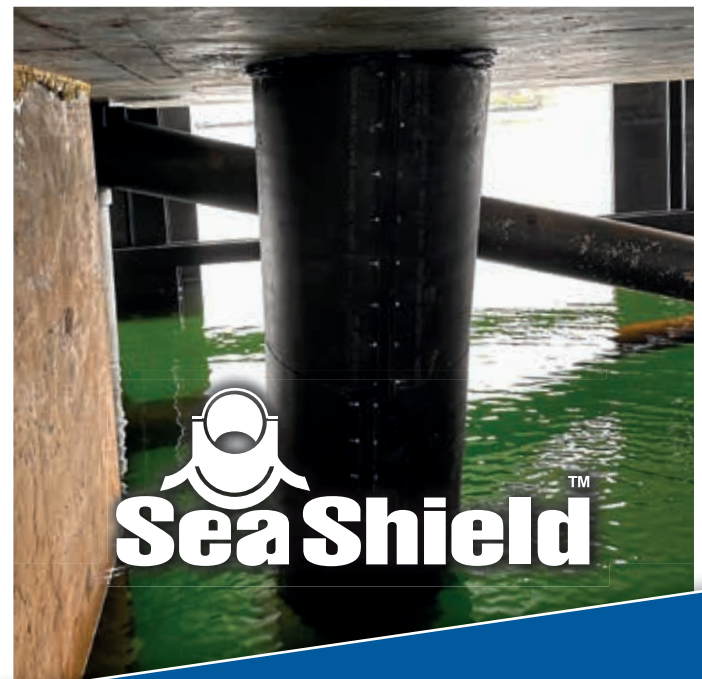
*The complete Seashield 2000FD System protecting one of the piles.*

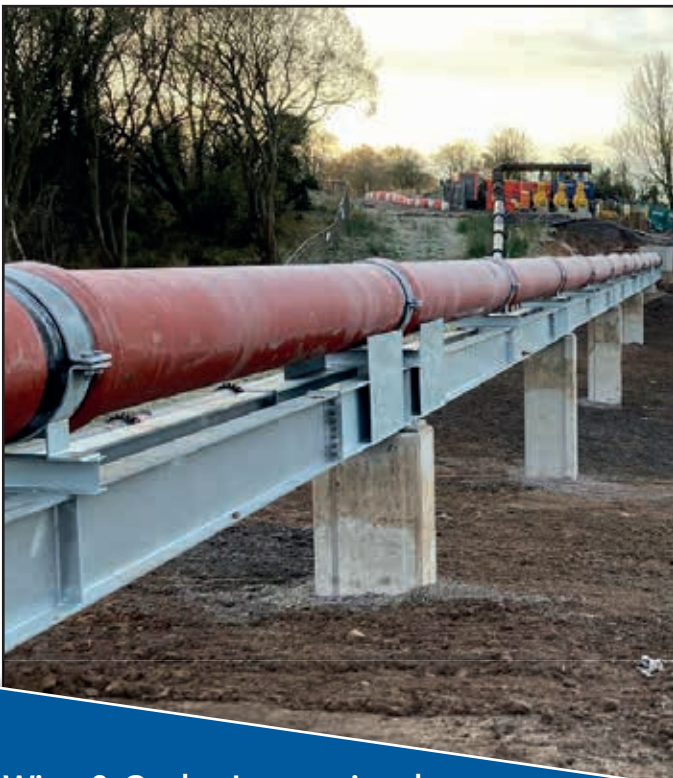
*Below: Pipe supports/touchpoints fixed into position, directly over the Denso™ Petrolatum Tape System wrapped sections of pipe.*

Pipe supports or touchpoints are one of the most critical areas of piping systems that must be protected from corrosion and mechanical damage. It generally occurs anywhere the pipe rests on a support or comes in contact with another structure. These hard to reach areas can, without notice, often result in pitting and crevice corrosion causing unexpected leaks.

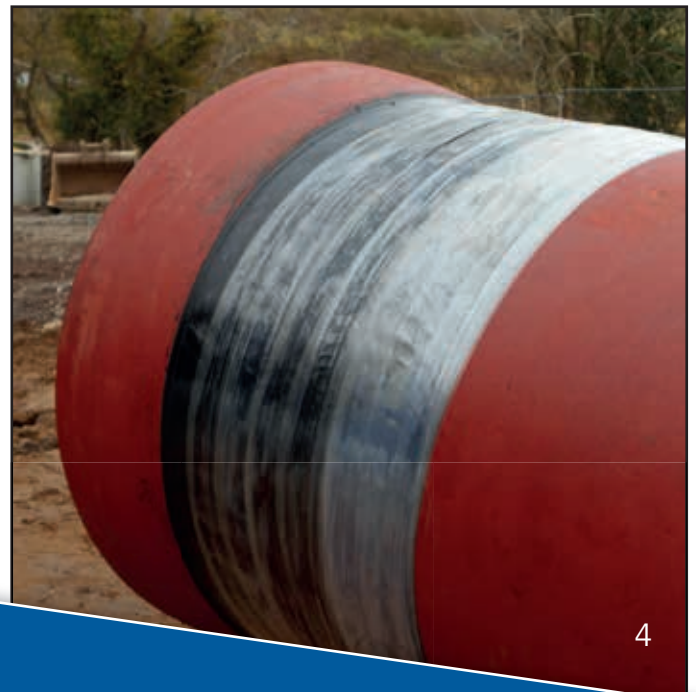
*Below: The Denso Petrolatum Tape System is applied to the pipe directly underneath where the pipe supports make contact.*

Sealing off this area from the environment and a good inspection program is critical to the long-term service life of the pipe. The solution proposed by Denso was to use the Denso™ Petrolatum Tape System comprised of Denso™ Tape, Denso™ SA PVC Outerwrap and Denso™ Glass Outerwrap UV. This complete system addresses and eliminates the corrosion and abrasion issues that can often cause damage to pipe support areas. The system was easily installed by hand without special equipment.

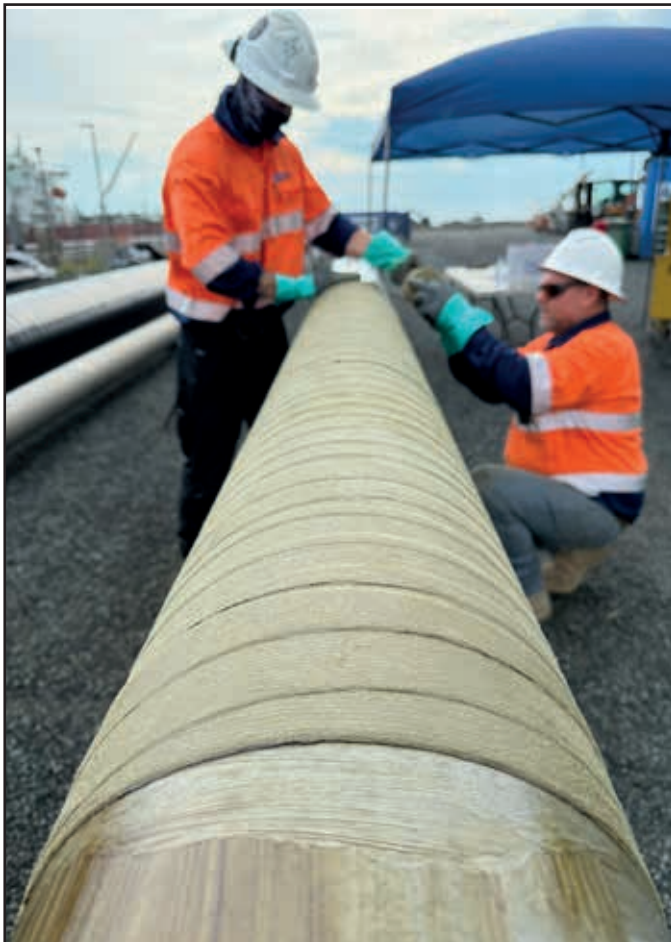
Application of the Denso™ Petrolatum Tape System to the jet fuel pipeline.

Stainless steel is highly resistant to corrosion, but when used in an ethanol pipeline carrying jet fuel, additional protection is required to prevent pitting and external environmental degradation. The combination of Denso™ MP Primer, Densyl™ Tape, and Denso™ PVC Outerwrap products were selected to form a robust protective barrier, ensuring the long-term integrity of this critical fuel transport line.

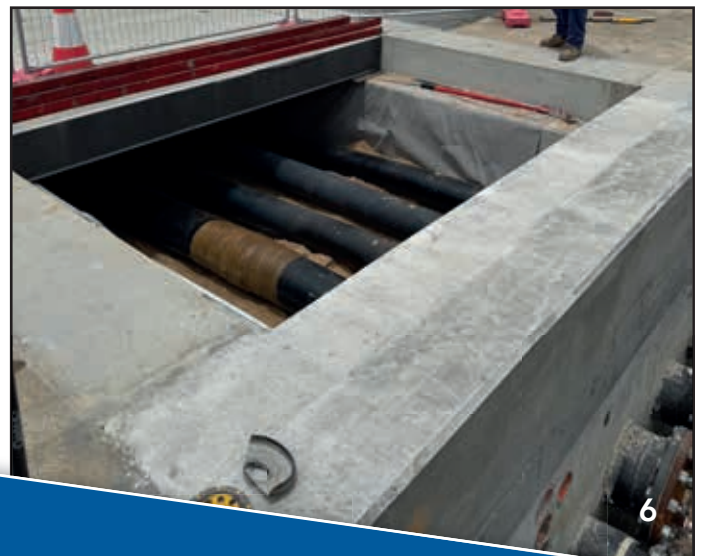
Below: View of buried pipelines post-application.

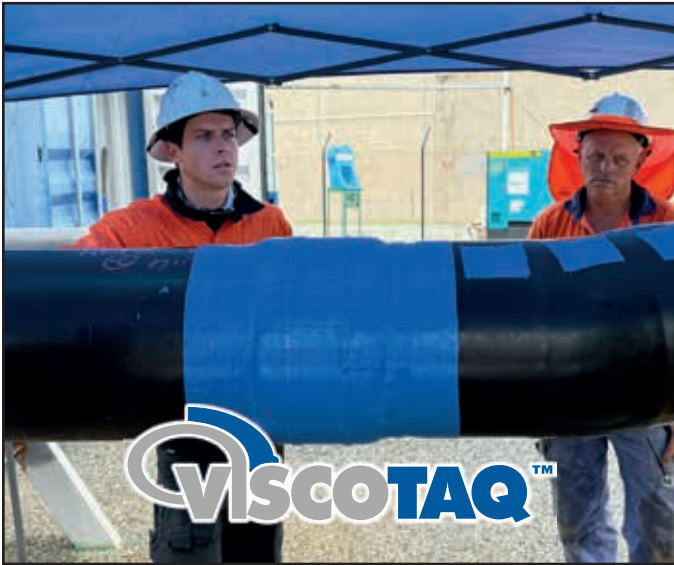
Above: Application of the Viscotaq™ System.

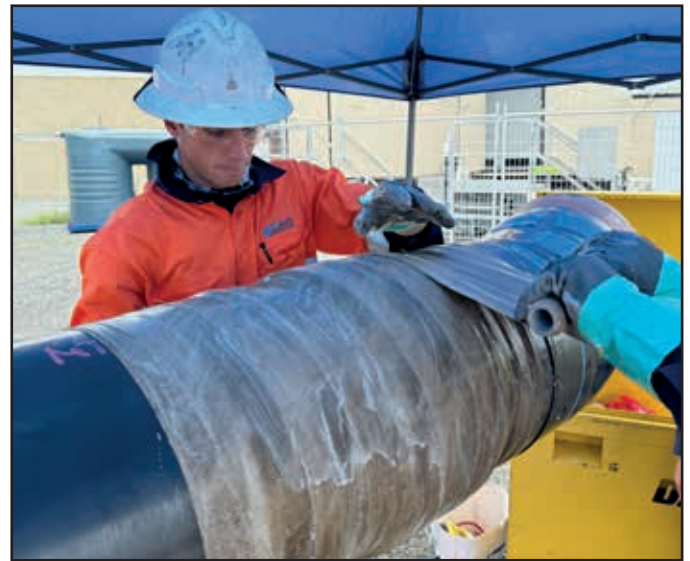
Above: Application of Denso™ Glass Outerwrap.

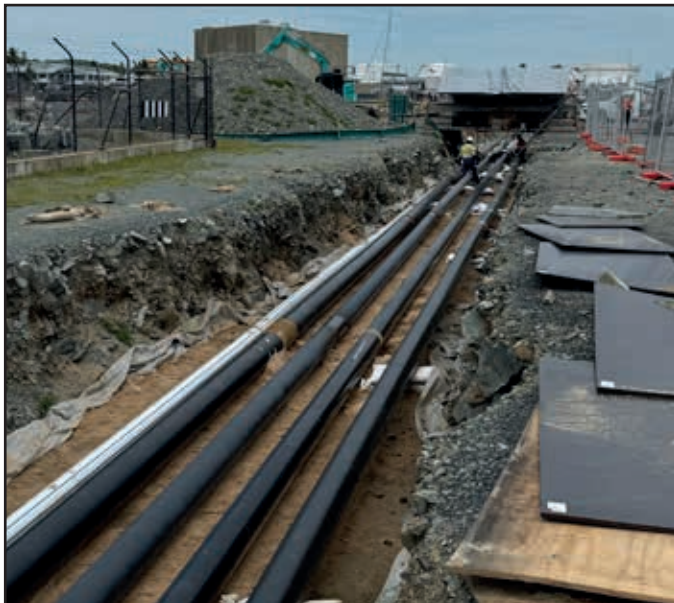
Above: Alternate view of the pipelines, post-application.

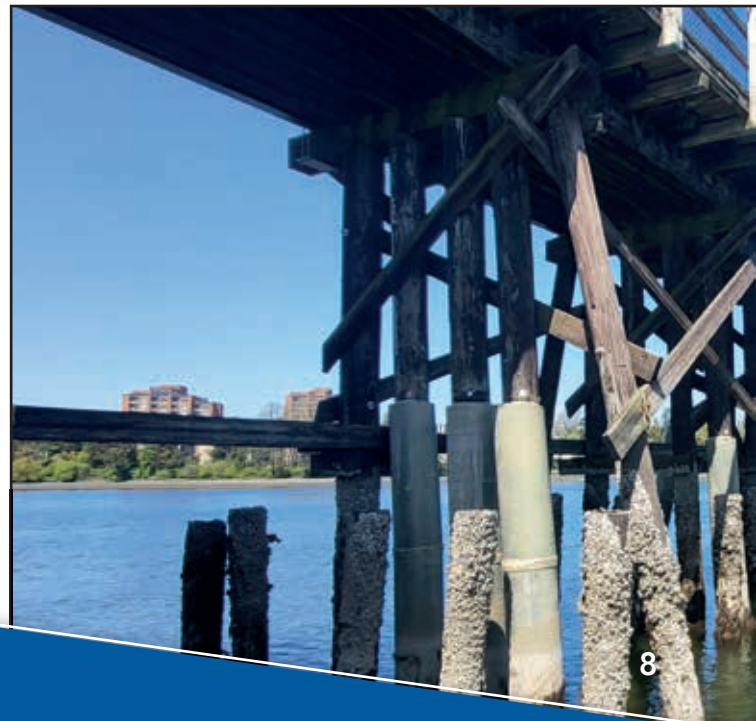
The SeaShield Jackets in place ready for the cavity fill of SeaShield 510 grout.

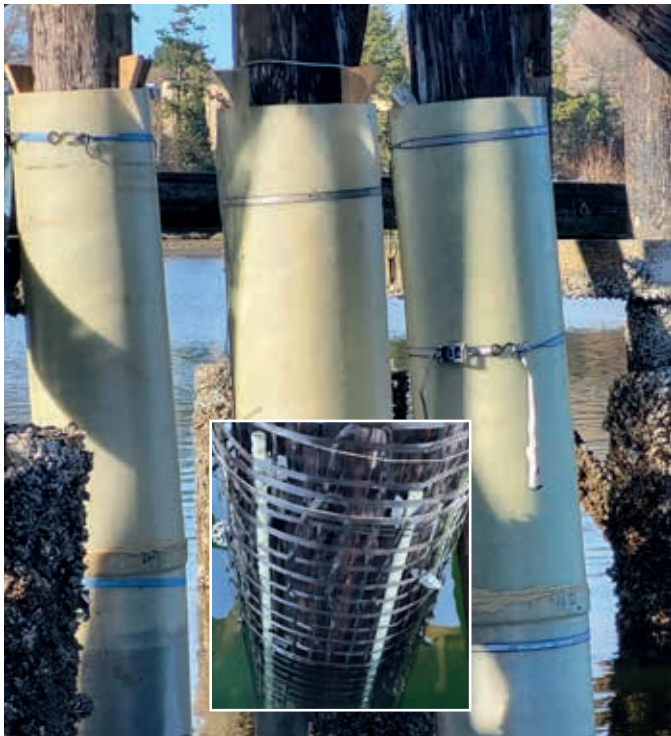
The completed SeaShield Series 400 System installed on the repaired piles.

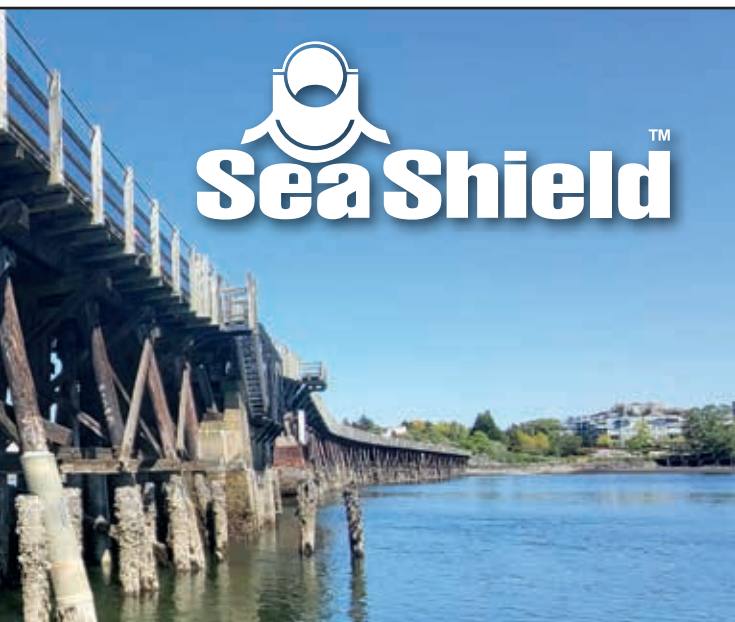
Left inset: The C-Grid Carbon Fiber double layer wrapped around the pile with fiberglass rebar before installing the SeaShield Series 400 FRP Jacket.

Salish Sea was chosen for the repair work to the Trestle and their product of choice would be the Denso SeaShield™ Series 400 system. Engineering group Stantec had initially chosen a legacy different product, but through meetings and consultation, we had the SeaShield Series 400 specified to be used instead. One area of concern was the strength of the reinforcing, so we developed a way to double wrap our C-Grid Carbon Fibre instead of the usual single wrap.

The Grid was then reinforced even more by adding 5/8" fibreglass rebar vertically. In the end Stantec was satisfied it would meet their requirements.

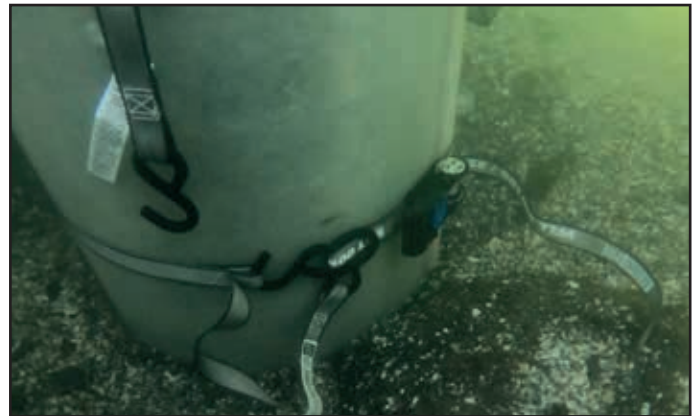
The SeaShield FRP Jacket at the mudline ready for plug to be installed.

Salish started the cleaning of the piles marked for repair and then working with divers in the water, started the process of spacing the C-Grid properly with the Fiberglass reinforcing rods. Then the correct spacing between the C-Grid, rods and Series 400 Jackets was worked out. Stiff tubes of pvc were adapted with camlocks and used to get the grout evenly distributed via tremme method right on the seabed to pour a plug.

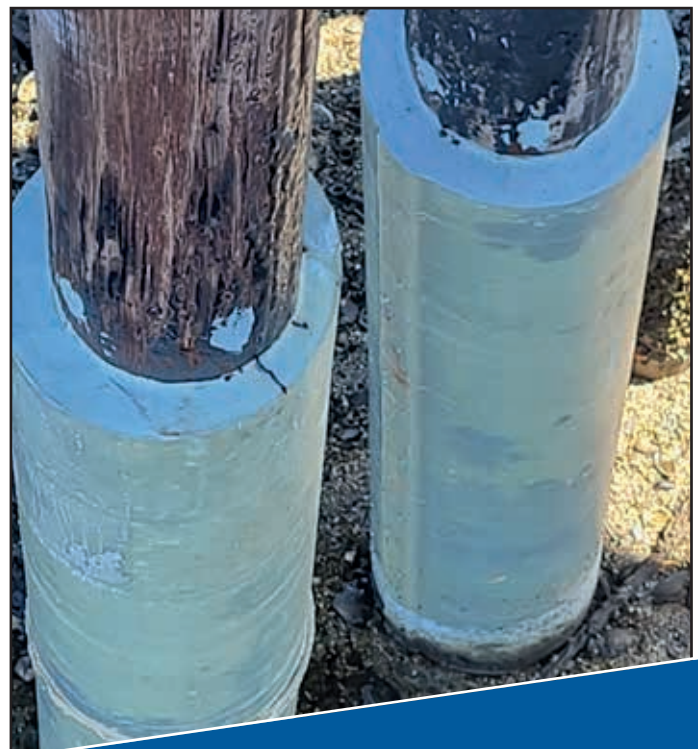
Top view of the completed grout filled jacket before installation of the SeaShield 526 Epoxy Bevel cap.

Once the plugs cured, the rest of the jackets were grouted at low tide to ensure a complete cavity fill of grout. In cases where an extra jacket was needed for height, we used bell and spigots to connect the 2 jackets with SeaShield FX70 grout, stainless screws and then proceed to grout with SeaShield 510 to the top of the jackets. After curing, SeaShield 526 epoxy was used to create bevel caps to finish off the jackets.

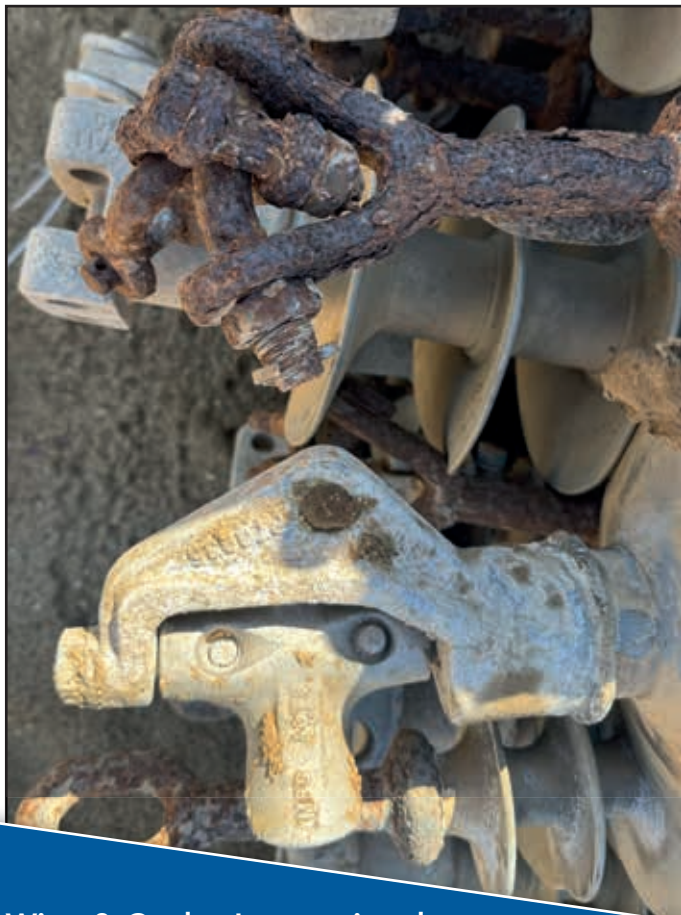
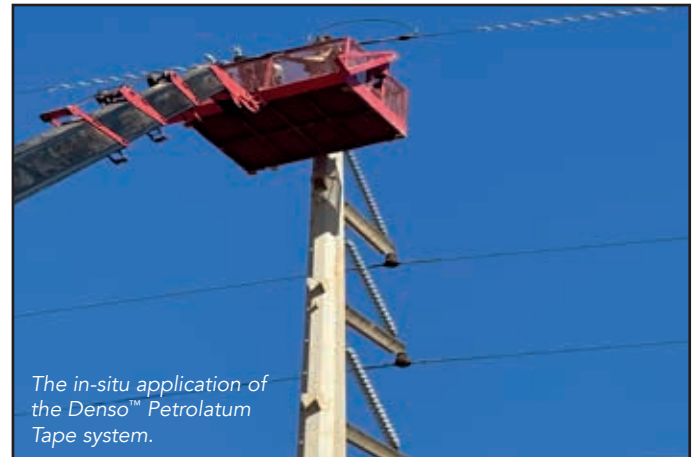
*Top of photo shows an example of the severe C5M level of corrosion of the galvanised metal caused by this environment. In complete contrast the Denso Petrolatum Tape System offered superior protection which can be seen on the lower item.*

An electrical contractor was tasked with replacing several sections of the high-voltage (HV) gantries due to severe corrosion on components that had not been protected with wrapping. The corrosion had progressed to the point where some of the steel parts were no longer structurally sound and had to be removed.

As part of this work, a number of Denso-wrapped sections were also removed, since they were connected to the corroded areas. Once the Denso wrapping was carefully taken off, the team inspected the components underneath and found them to be in excellent condition - with no signs of corrosion or damage. These parts had been fully protected, even after long-term exposure to Walvis Bay’s harsh C5M-rated coastal environment.

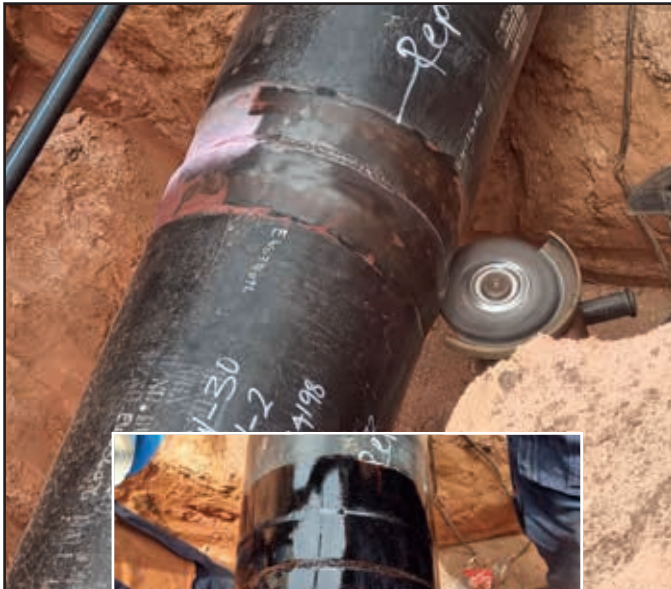
Preparation of the welded joint surface, using a hand-held power tool.

The surface was prepared using a hand-held power tool. Thereafter Denso Primer D™ was applied to the surface of the field joints. This primer was chosen for its excellent adhesion properties, ensuring a strong bond between the joint and the protective materials.

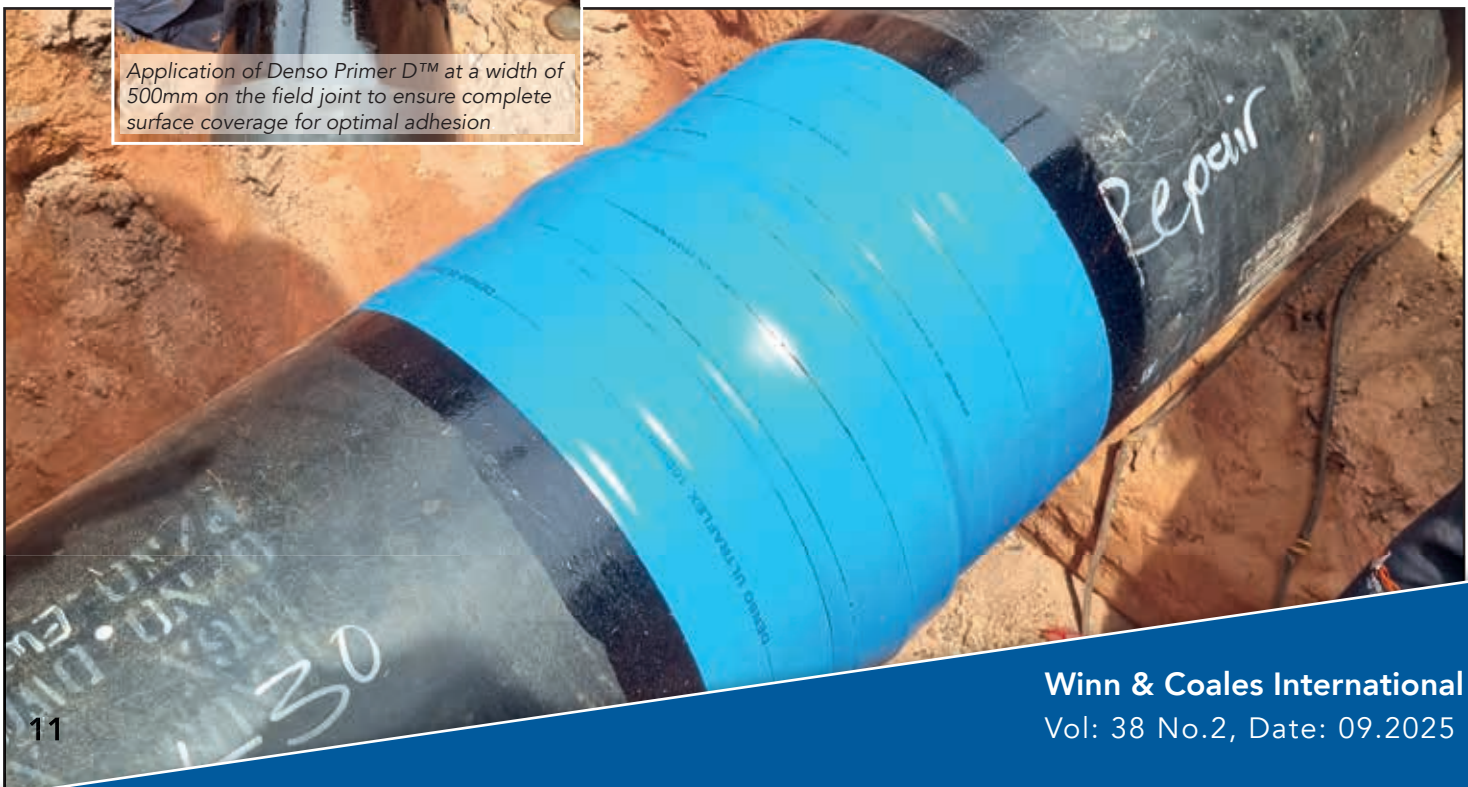
Below: The completed Denso welded joint protection.

Next, the joints were wrapped with Denso Ultraflex™ 1250. This tape was selected for its superior corrosion prevention capabilities. Each joint is carefully wrapped, and the PVC backing of Denso Ultraflex™ 1250 provides additional mechanical strength, safeguarding the joints from external elements.

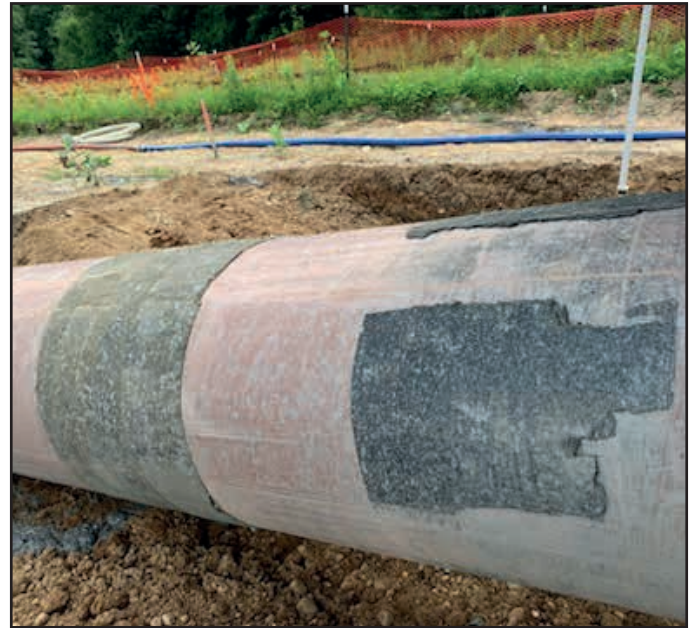
*Opposite: The Denso Bore-Wrap at the leading edge is still in place 360° around the pipe.*

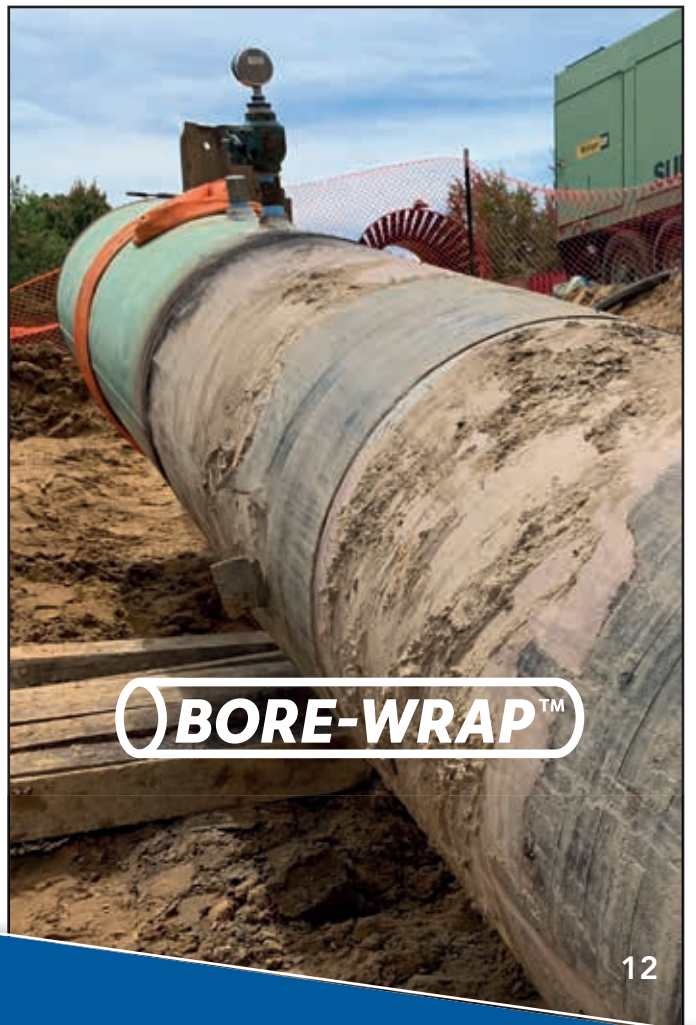
Above: The Denso Bore-Wrap™ is fully intact on the left after the pull.

On the first section, the Denso Bore-Wrap™ was installed at the lead end of the pipe followed by an outerwrap from a different manufacturer. On the second section the Denso Bore-Wrap was applied as the second wrap on the pipe. Upon completion of the pull both outerwraps were inspected. The Denso Bore-Wrap proved to be the superior product in both locations. When placed first at the leading edge, the Bore-Wrap held up 360 degrees around the pipe after an initial gouge that did not make it past the very first circumferential double layer whereas the product supplied by the different manufacturer was gouged completely through at various areas throughout the full 360 degrees. This proves how the Bore-Wrap fabric sets itself apart from other types of abrasion resistant outerwraps. The multidirectional weave provides exceptional resistance in all directions preventing rocks from finding a seam and tearing completely through the path of least resistance. When placed second, the Bore-Wrap was still completely intact 360 degrees around the pipe. In both locations the Bore-Wrap completely protected the underlying anti-corrosion coating.

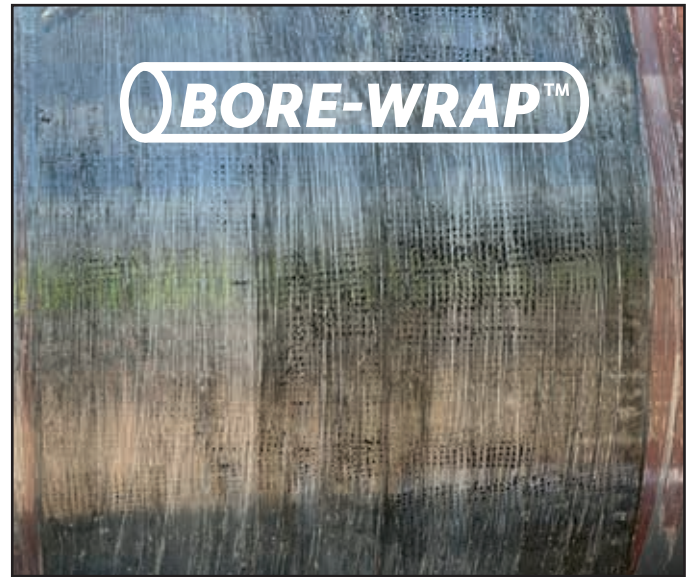
Above: The perforations allowing excess gas, resin, and water to escape during the curing process

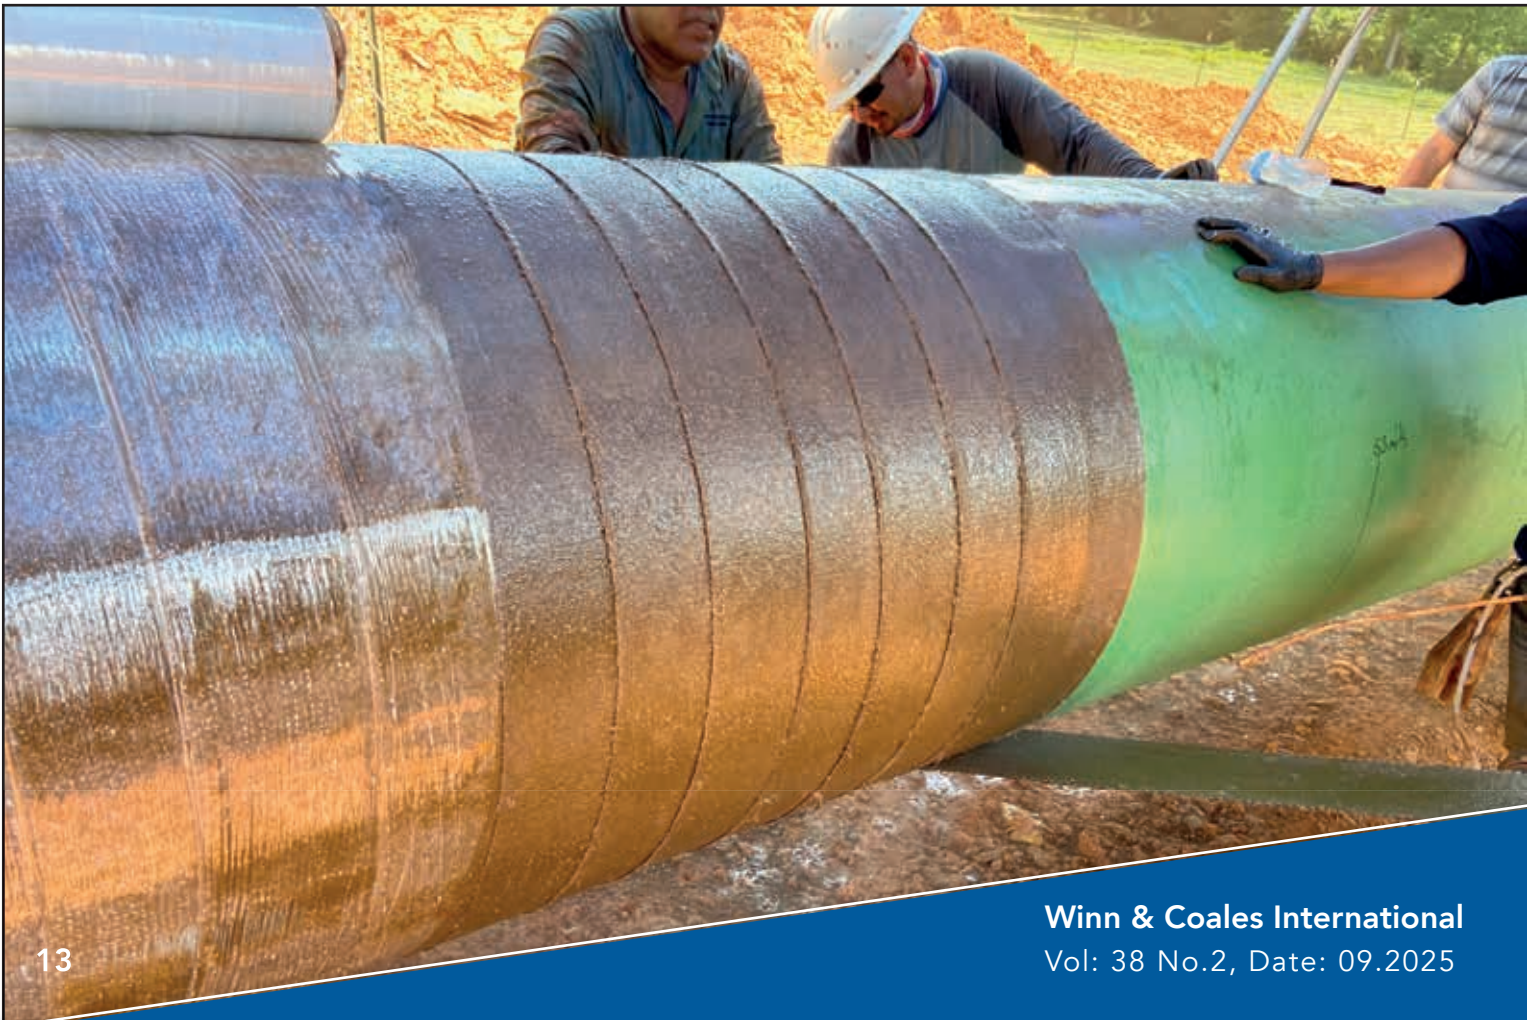
Below: Application of the Denso Bore-Wrap System

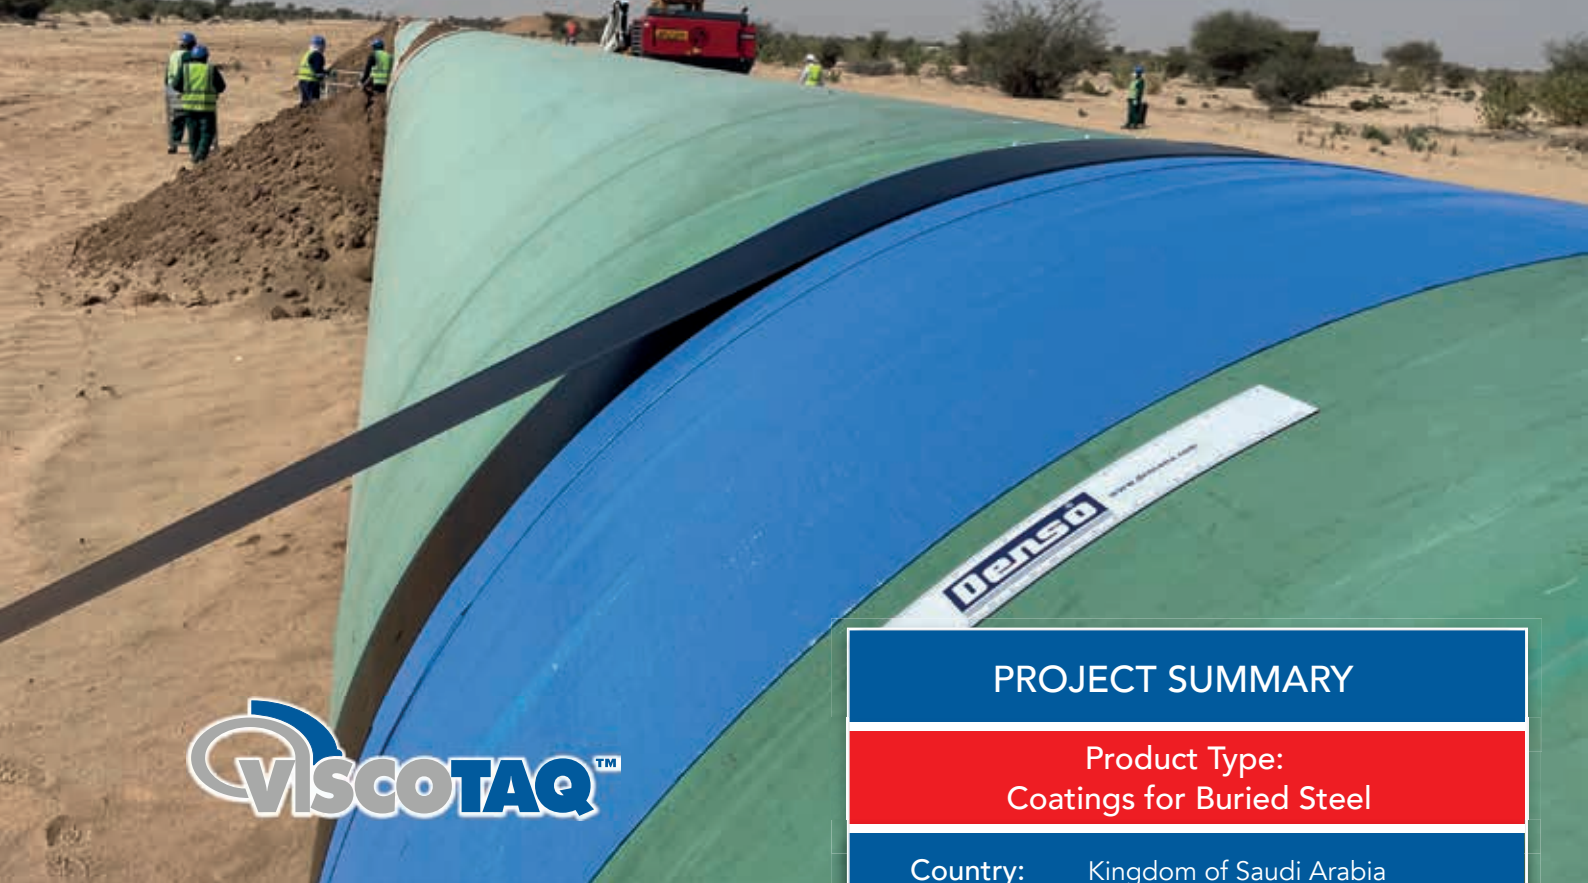
The Master Gas System Expansion Phase III in progress with girth welds receiving the Viscotaq™ HT System protection.

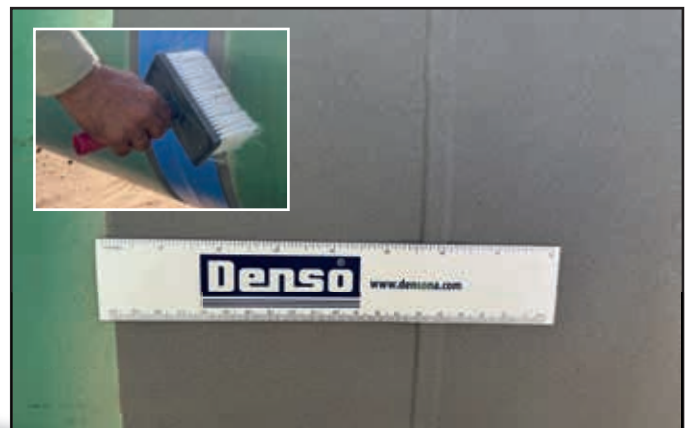
The girth weld is cleaned before application of the Viscowrap HT Tape. Inset: Regular brushing of the prepared substrate to remove airborne dust and sand during the application, is unavoidable in a desert environment.

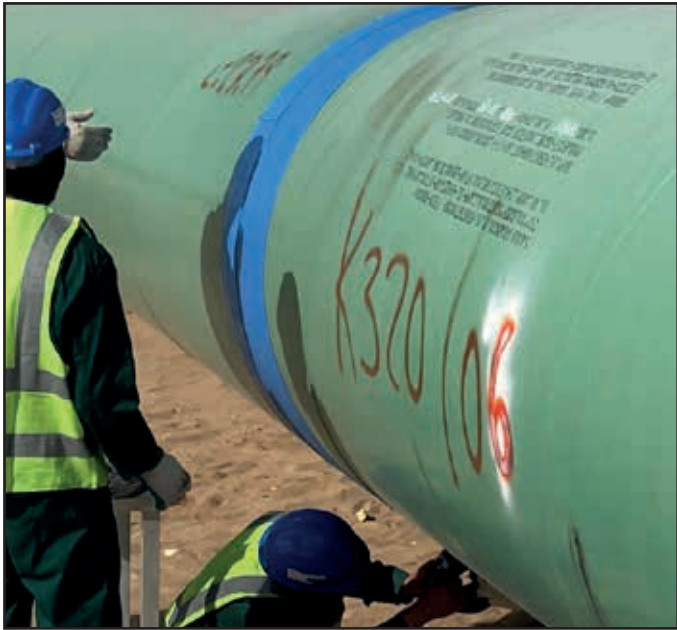
*Application of the Viscotaq HT Tape.*

For long term protection Denso's Viscotaq™ HT System has been specified to protect 10" and 56" diameter girth welds on the gas pipeline. The system comprises an inner layer of ViscoWrap™ HT Tape with an outer layer Viscotaq™ PVC Outerwrap.

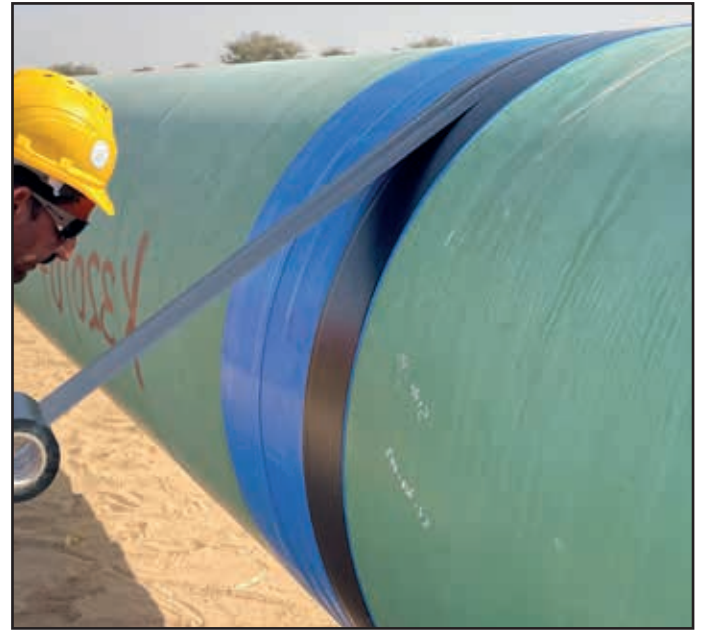
*Application of the Viscotaq PVC Outerwrap.*
