# DENSO DIGEST

Winn & Coales International Ltd

Volume 38, Number 4

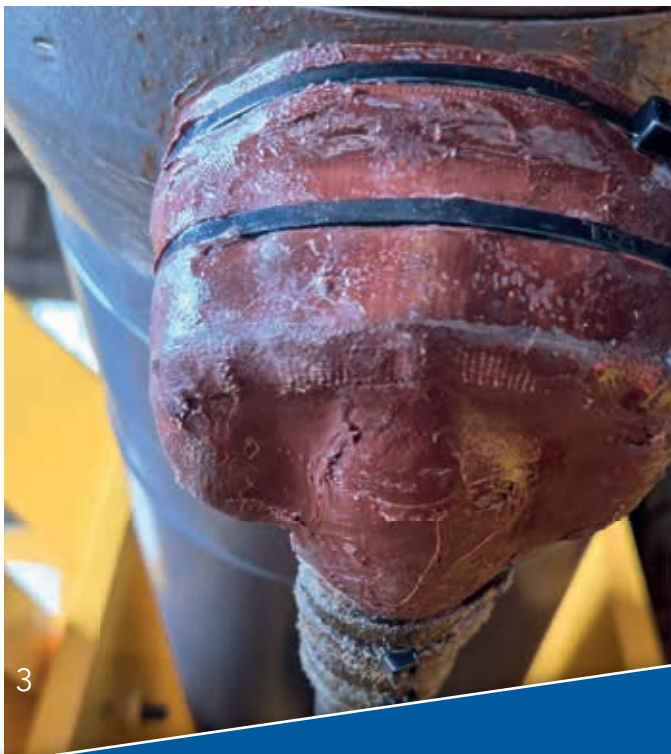
*Below and right: Some of the vulnerable areas on the mechanical equipment that benefit from Denso protection.*

The use of Denso™ Tape, Densyl™ Tape and Denso Hotline™ Tape which cover a wide range of temperature requirements have proved highly successful even when the equipment is used by industries which handle very aggressive corrosive materials such as polyhalite and rock salt.

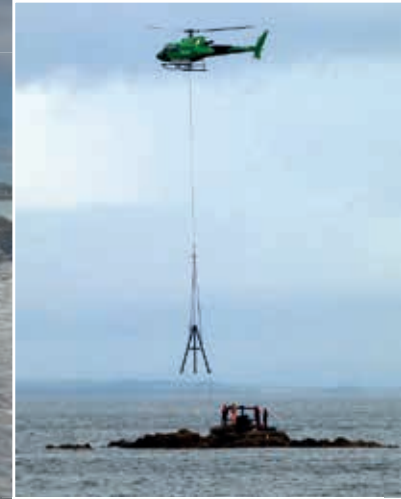
The new light structure being airlifted into place by helicopter.

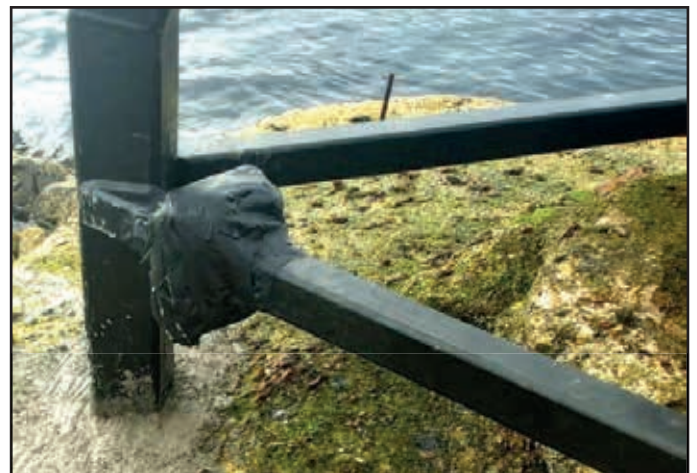
To maximise the life of the structure the Steelcoat 100/400™ System was applied to all the bolted joints on the structure, which due to the remote location was then airlifted in sections by helicopter and bolted into position on site.

The Steelcoat 100/400 System which consists of Denso Hi-Tack™ Primer, Denso Profiling Mastic™, Denso Hi-Tack™ Tape, Denso™ Ultraseal Tape and Denso™ Acrylic Topcoat has a proven track record in providing protection for above ground structures."

The bolted joints on the new light structure were protected with the Denso Steelcoat 100/400™ System.

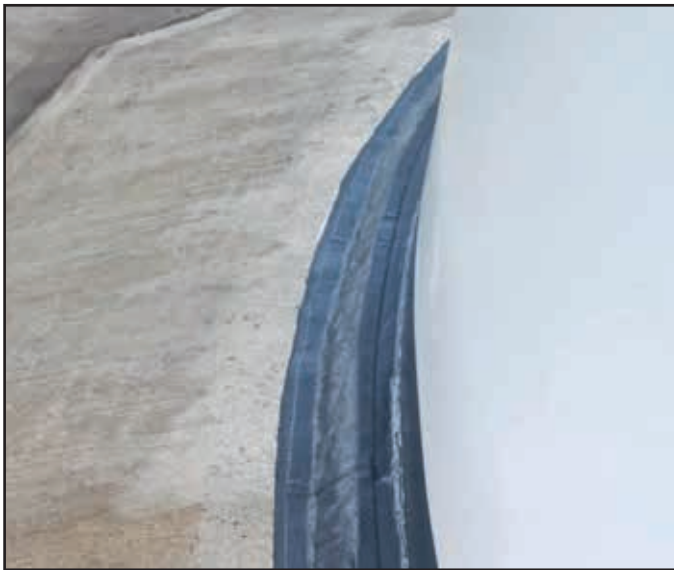
The Viscotaq™ Chime Sealing System applied to the fuel storage tank.

The Viscotaq™ Chime Sealing System was used to prevent water infiltration at the concrete ring wall interface of the tank, a place where corrosion normally occurs. The Viscotaq System can be installed on new and existing facilities, can be painted immediately after installation, and does not interfere with any future paint, inspection.

The Viscotaq Tank Chime Sealing System comprises Viscosealant™, or ViscoPutty™ and Viscotaq™ EZ Wrap.”

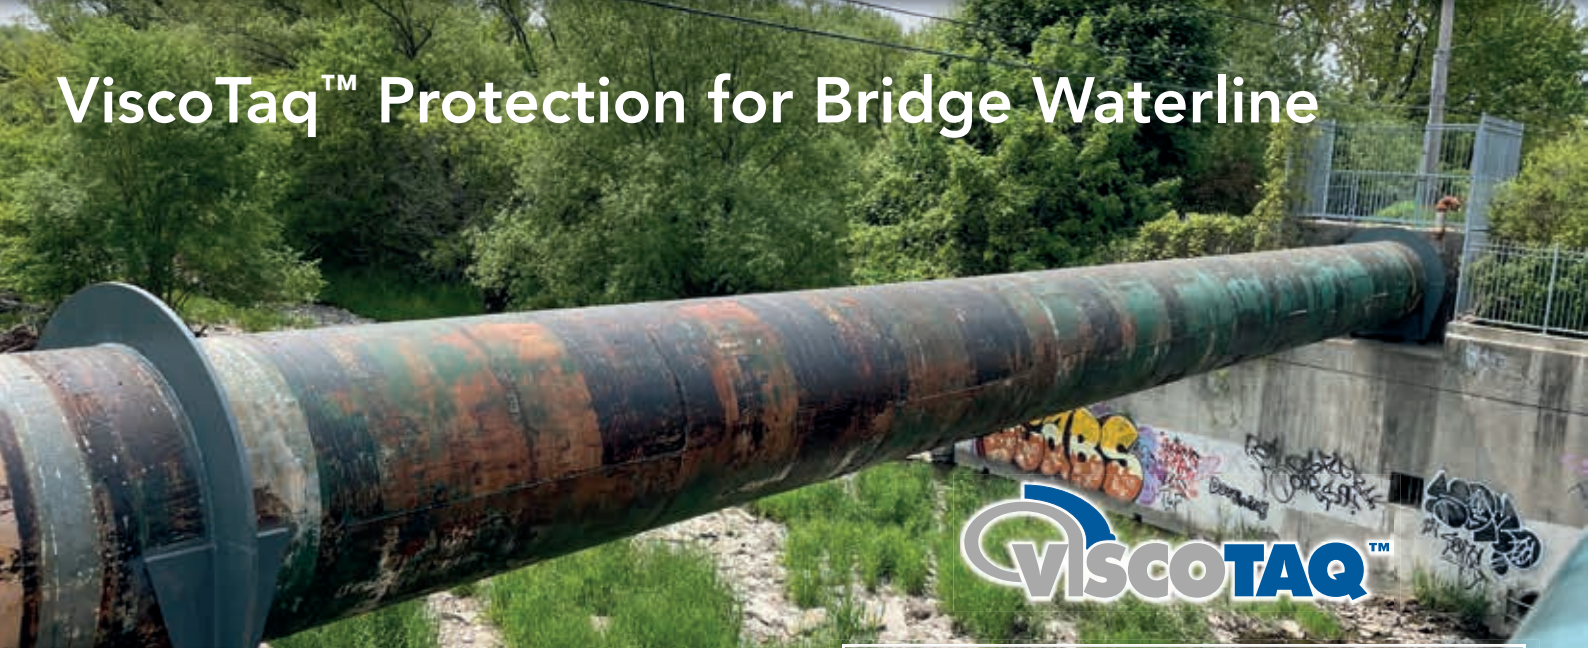
The bridge waterline cleaned and ready for the Viscotaq System.

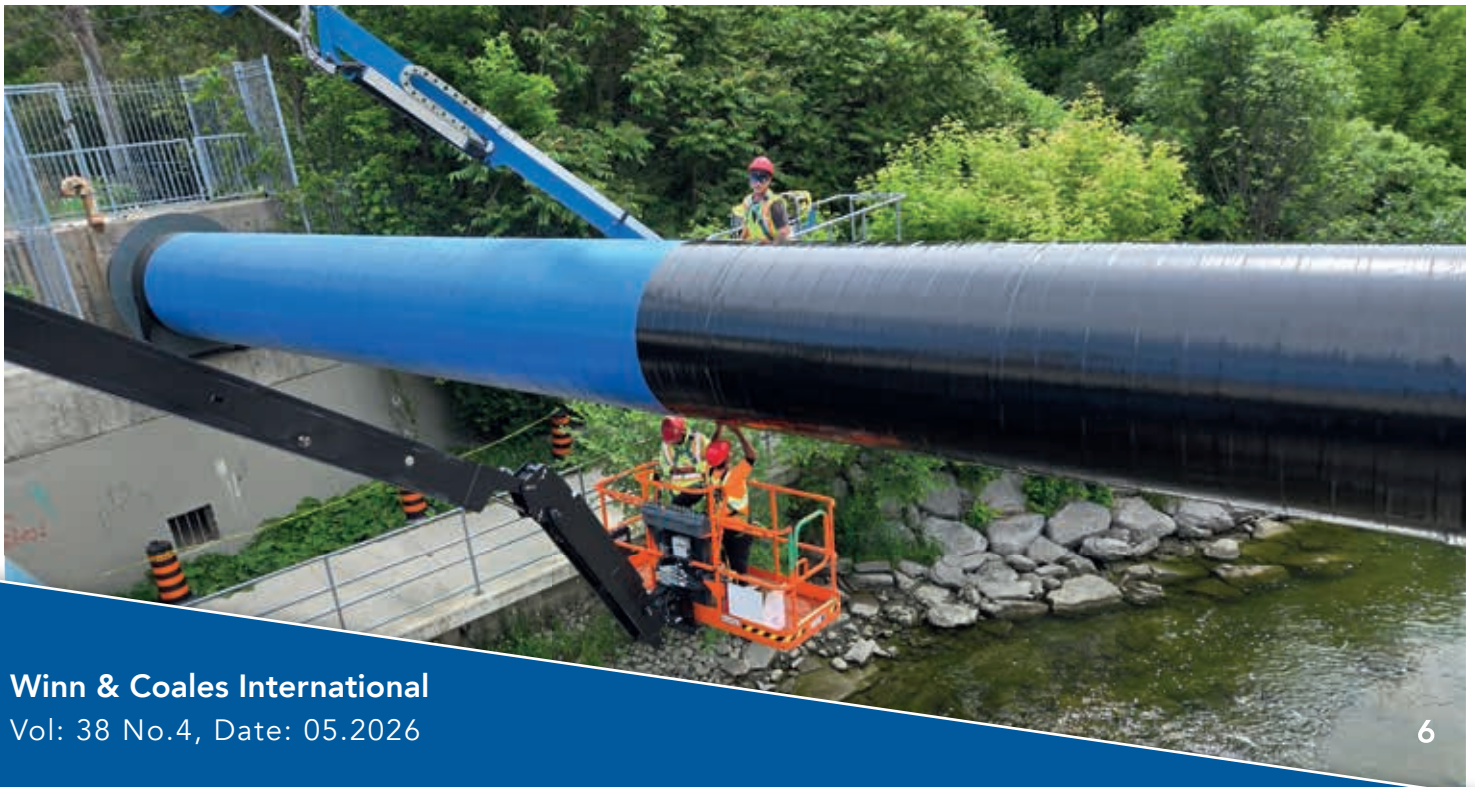
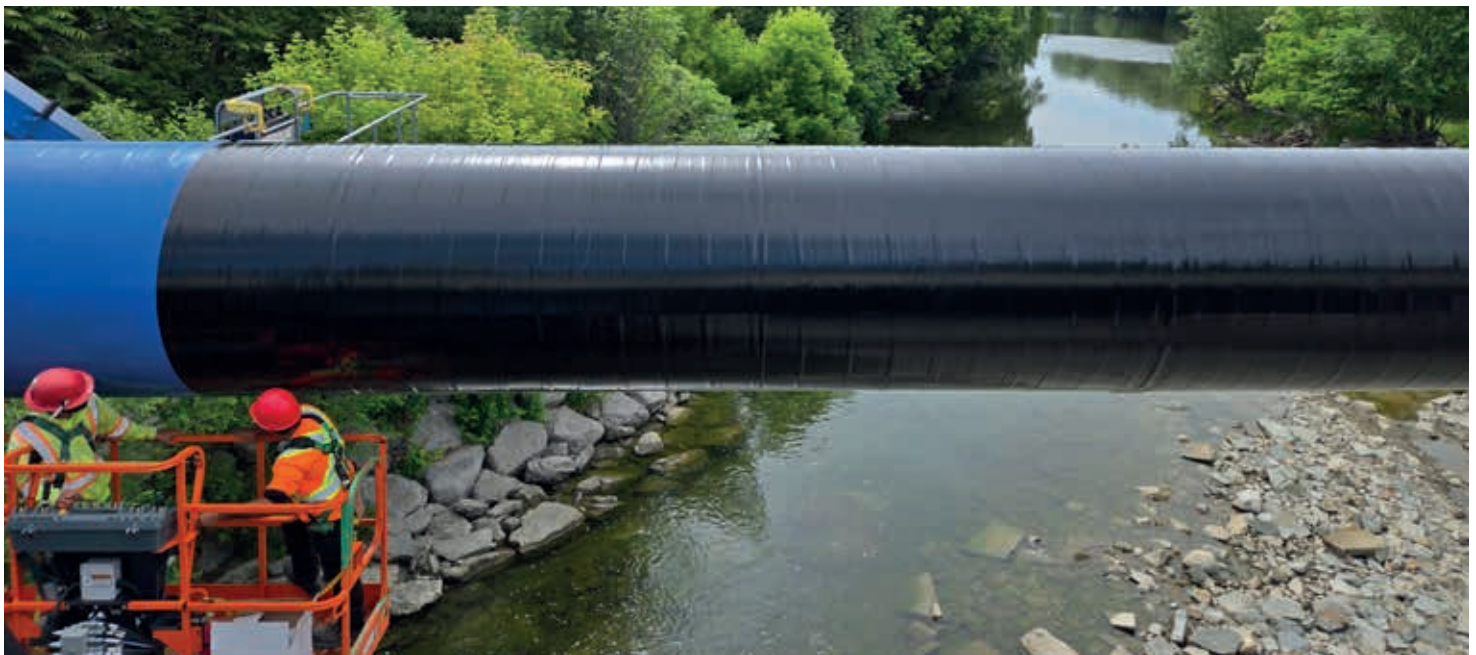
Below and top of page 9: A wrap of ViscoWrap™ ST (blue) is followed by a wrap of ViscoWrap™ PE (black).

To meet the challenge, Denso was chosen to provide its industry-leading corrosion prevention technology. After thorough consultation and technical review, Denso recommended its Viscotaq ViscoWrap™ ST along with ViscoWrap™ PE Outerwrap solution. This combination provided a high-performance, robust protective tape system, paired with a PE Outerwrap to deliver an additional layer of UV and mechanical protection. This solution allowed for an effective, easy-to-apply, and maintenance-friendly system perfectly suited for exposed steel in challenging outdoor environments. The project required precision and expertise, with teams carefully applying the Viscotaq system using various lifts to ensure complete coverage and application along the pipe's entire length.

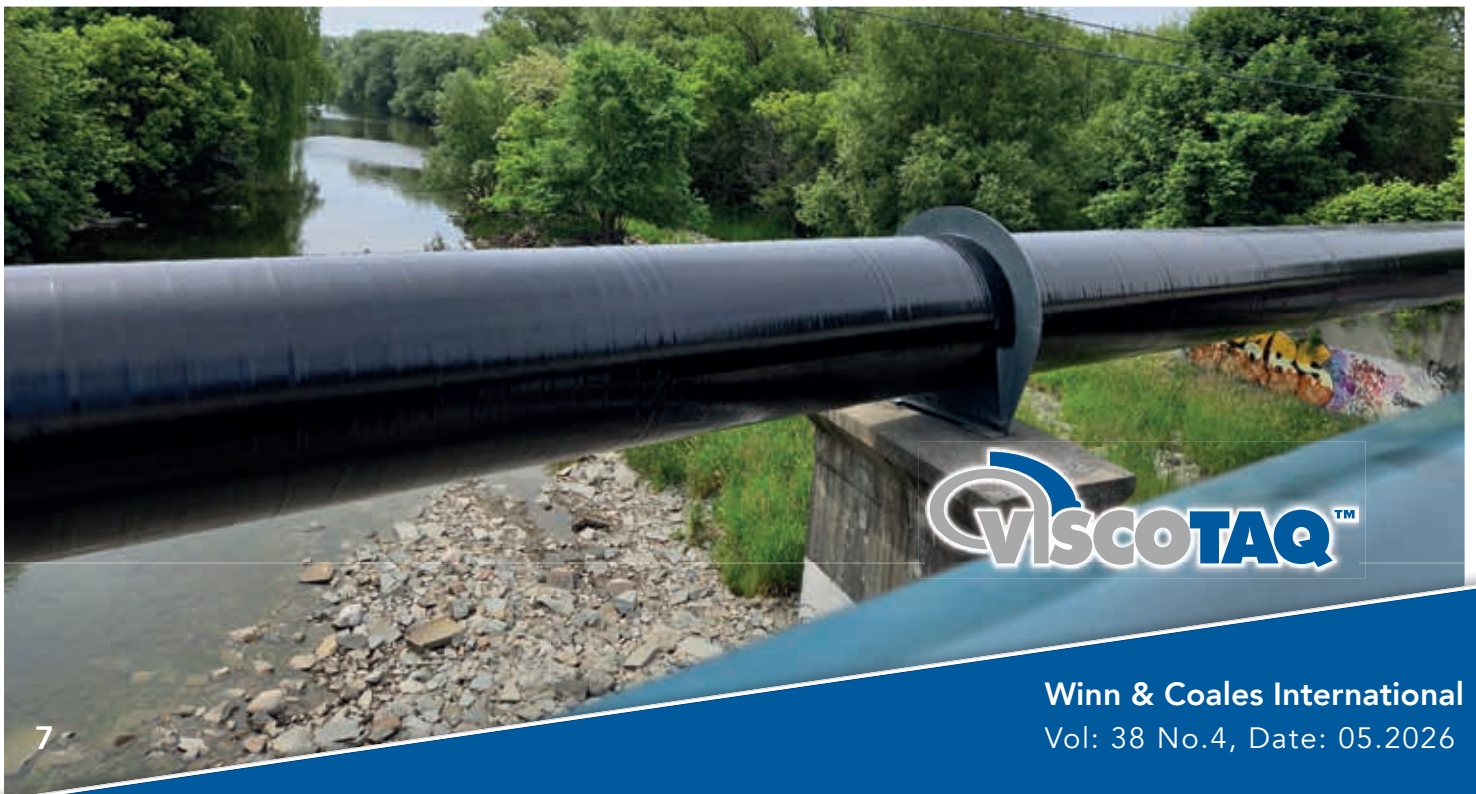
Below: A wrap of ViscoWrap™ PE Outerwrap completes the protective system.

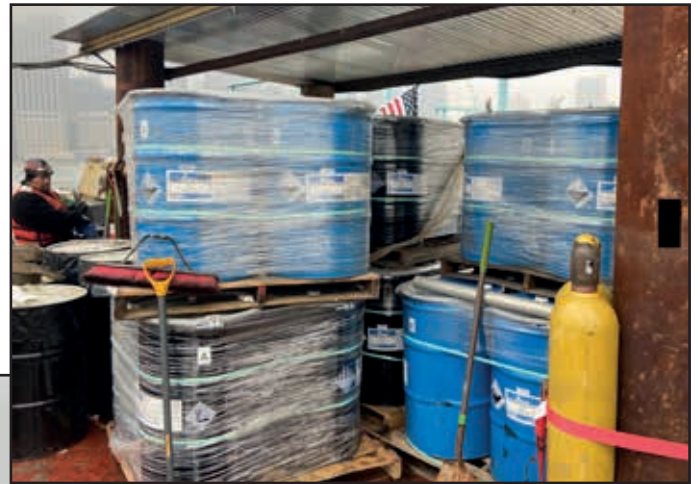
Above:  
SeaShield 550™ Epoxy Grout  
(165 gallon kits).

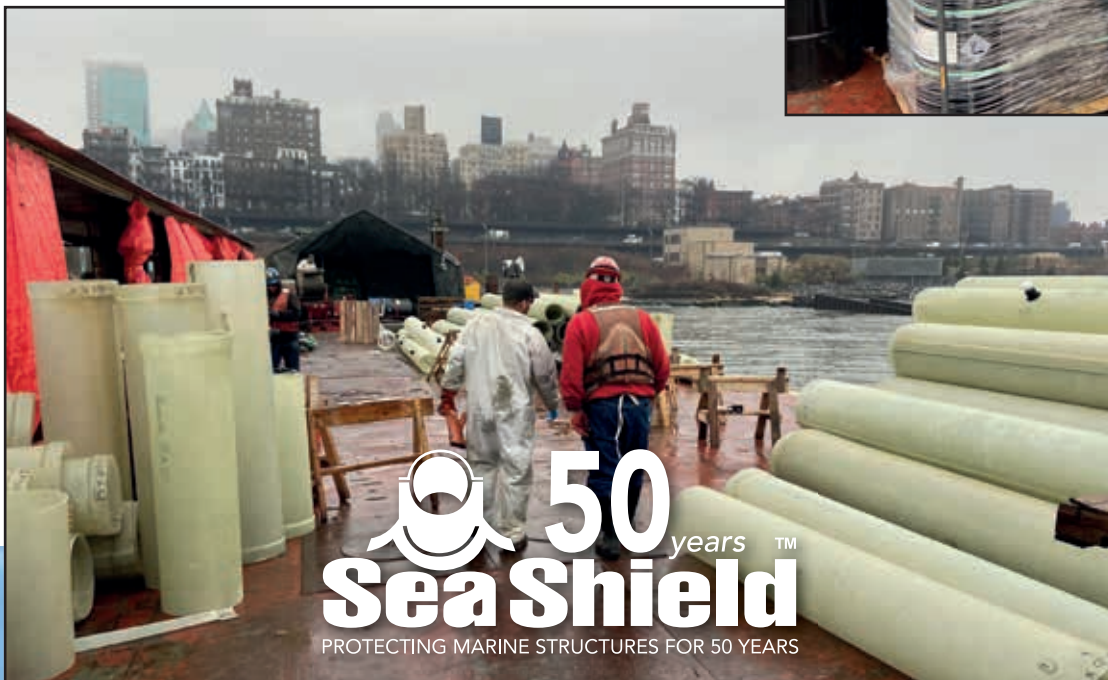
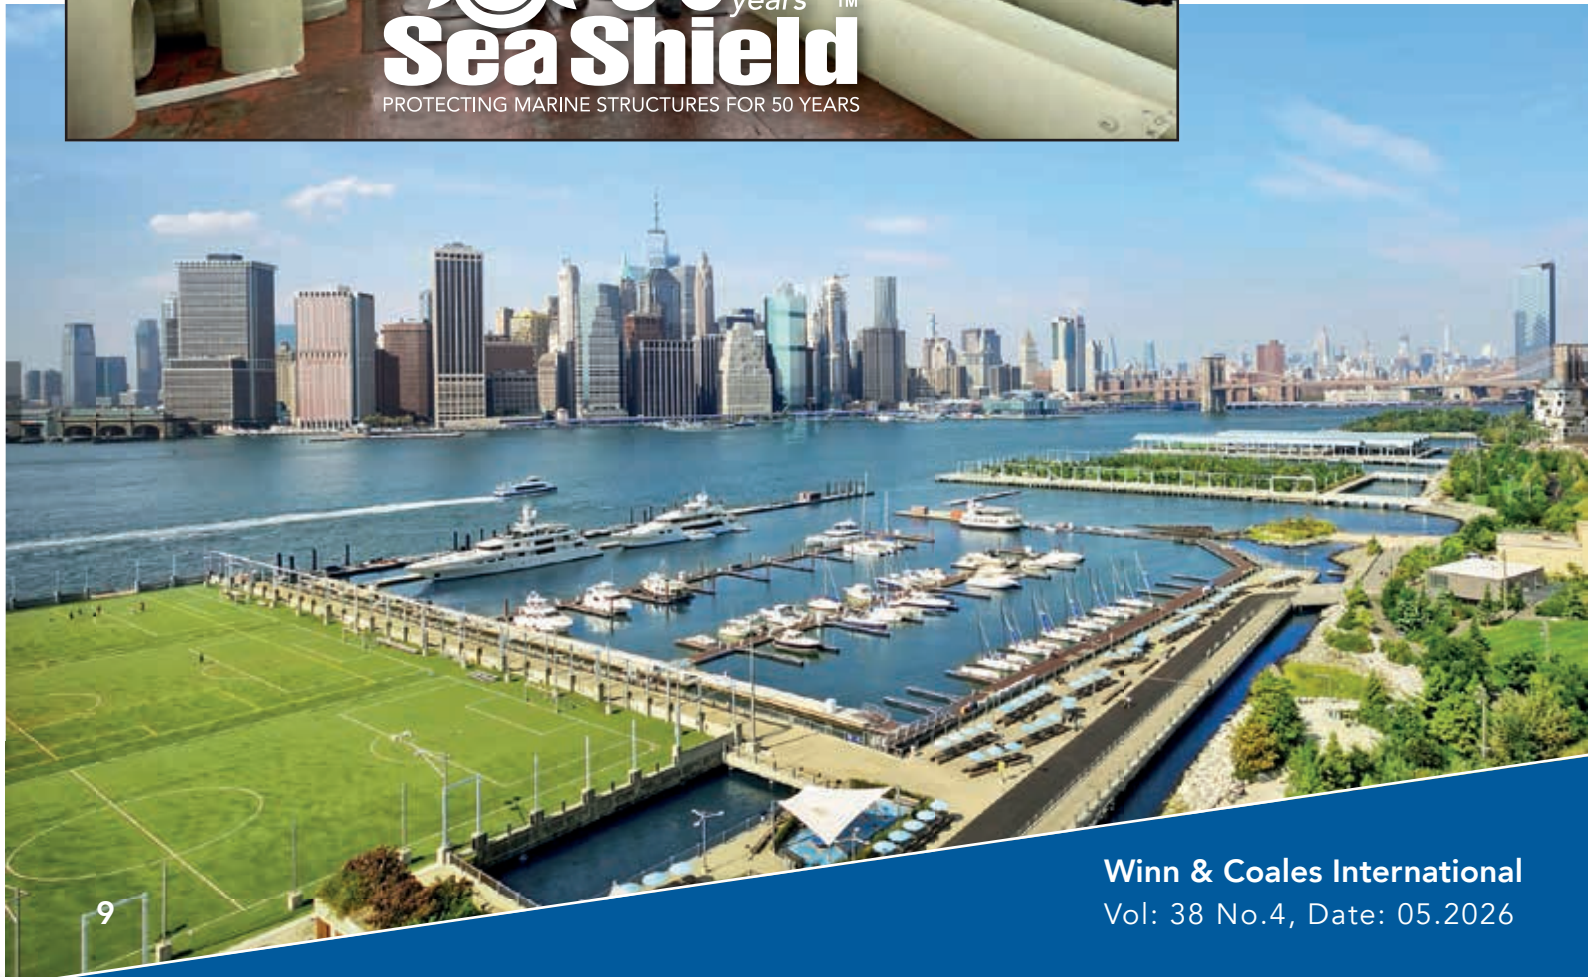
Left:  
SeaShield™ Fiber-Form Jackets  
staged on barge.

The system not only encapsulated the piles to halt ongoing deterioration, but also restored their structural integrity by filling voids and reinforcing damaged sections with high-strength epoxy grout. This dual action of protection and rehabilitation ensured the piles could continue to support the bridge for decades to come. Thanks to the efficiency of both the product and the contractor, the project was completed ahead of schedule in 2021, leaving Brooklyn Bridge Park with a stronger, more resilient foundation.

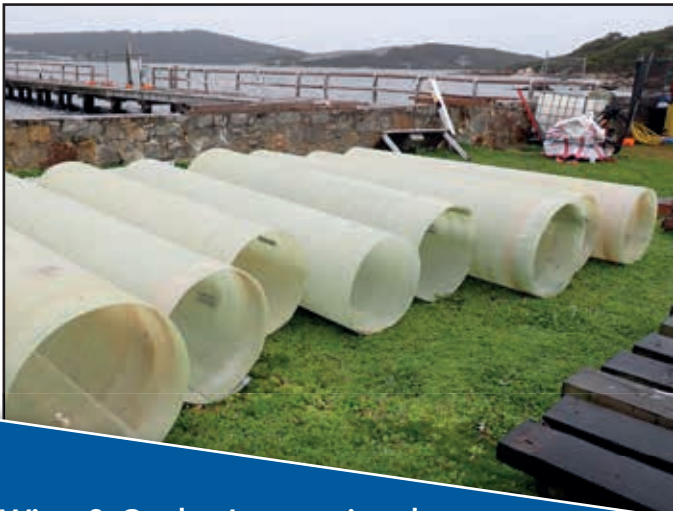
SeaShield™ Fibre-Form Jackets ready for installation.

SeaShield Fibre-Form jackets, each with a 6m length were supplied and installed to restore structural strength to deteriorated timber piles and provide protection from further decay.

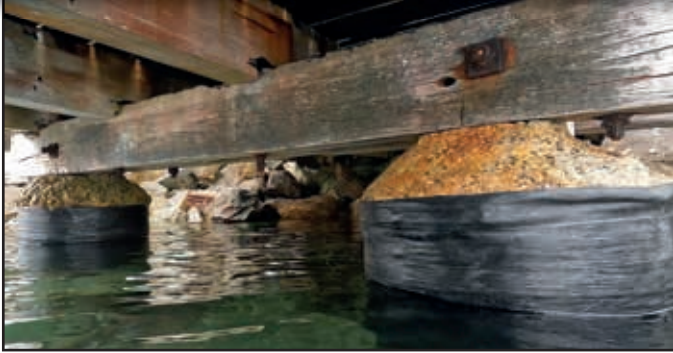
**SeaShield 70™ System** - SeaShield™ Primer, Denso Marine Piling Tape™ and Denso™ Glass Outerwrap UV. Applied to new and existing timber piles each with a 500mm OD and a length of 3.2m. On existing timber piles, this system was selected to protect the pile from further deterioration (primarily through worm and borer infestation) while they were still structurally adequate. For new piles, the SeaShield 70 system provided immediate defence against the aforementioned erosion factors.

The completed SeaShield 70™ System.

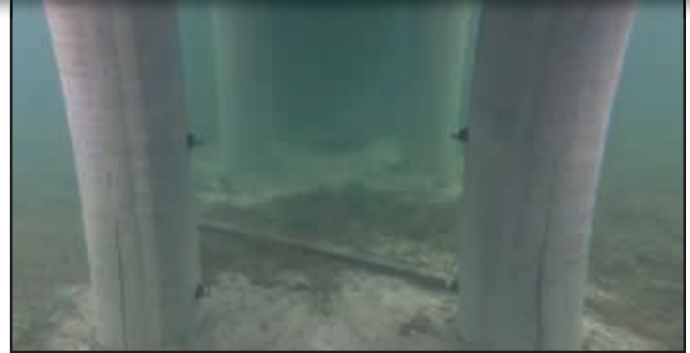
**SeaShield 400™ System** - C-Grid 450, SeaShield™ Fibre- Form Jackets, and either SeaShield 510UW™ (cementitious underwater grout) or 550™ Epoxy Grout was used to fill the annulus between the pile (and any reinforcement or grid) and the inside of the jacket, restoring structural strength and ensuring the pile is encased.

Underwater view of the completed SeaShield 400™ System.

Jackets were installed sequentially, filled with cementitious grout, and sealed. Translucent jackets allowed divers and applicators to visually monitor grout flow, ensuring complete coverage. Where visibility was poor, grout was pumped until it exited at the next port, thus providing applicators with another means of confirming sufficient coverage. Contractors reported straightforward installation and grout pumping, aided by the lightweight jackets and intuitive sequencing.

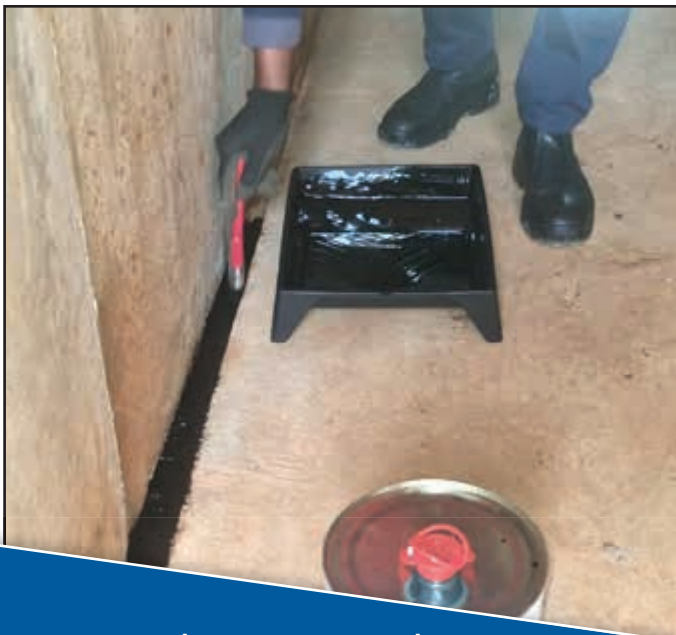
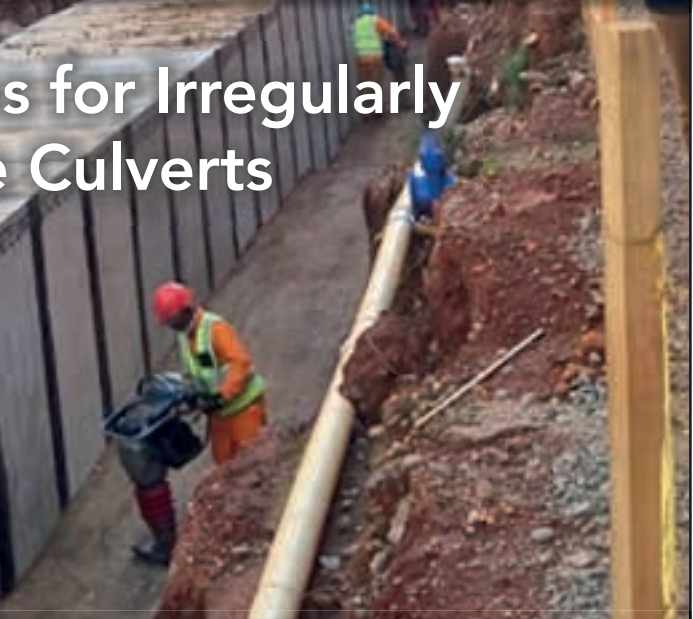
Denso recommended Denso Primer D™, combined with Butyl mastic and Densotherm HD Tape™, as the most suitable system for sealing the internal joints of the culverts.

*Denso Primer D™ and Denso™ Joint Sealer being applied on the inside of the culverts that have already been stacked.*

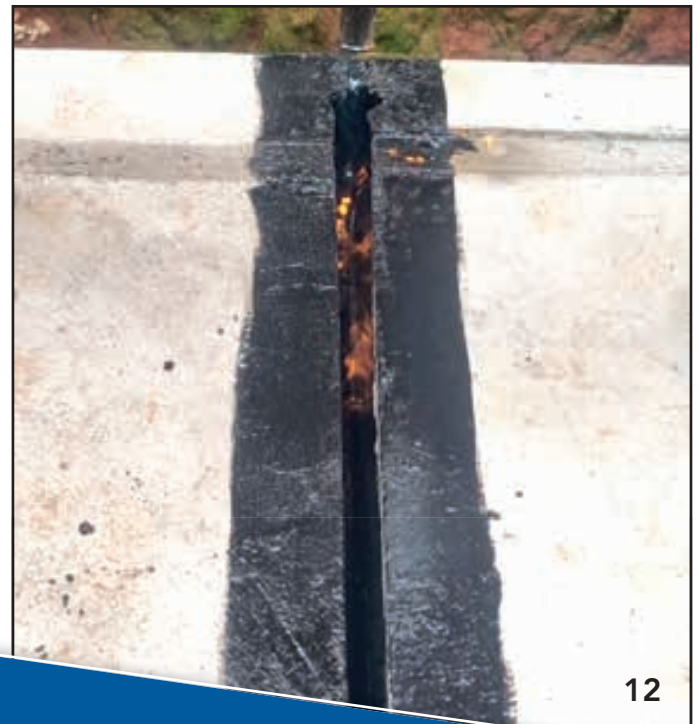
For the external sections, with flatter surfaces, Denso proposed the Denso Premseal 100™ tape system. Denso Premseal 100™ is a durable sheeting made from cross-laminated, orientated high-density polyethylene, coated with a strong adhesive polymer-modified bitumen compound.

*Denso Primer D™ & Denso™ Joint Sealer applied for all new concrete bases placed forward (external section).*

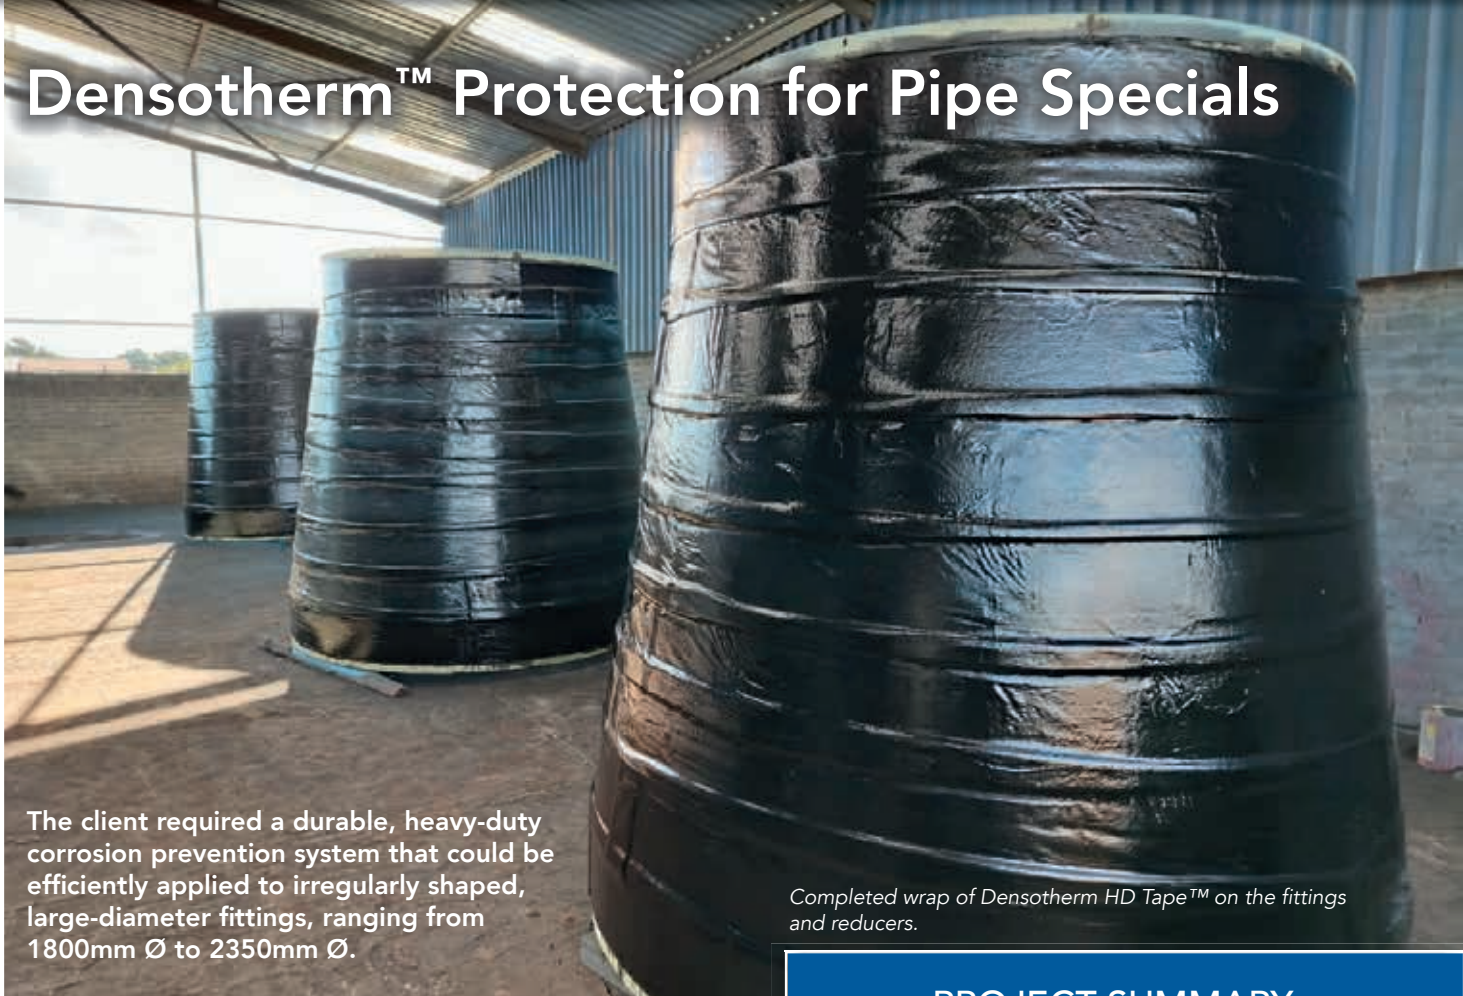
Completed wrap of Densotherm HD Tape™ on the fittings and reducers.

Denso proposed a 5mm heavy-duty, torch-applied Densotherm HD Tape™ system, incorporating Denso™ Butyl Profiling Mastic filler to accommodate the irregular shapes and sharp edges of the fittings.

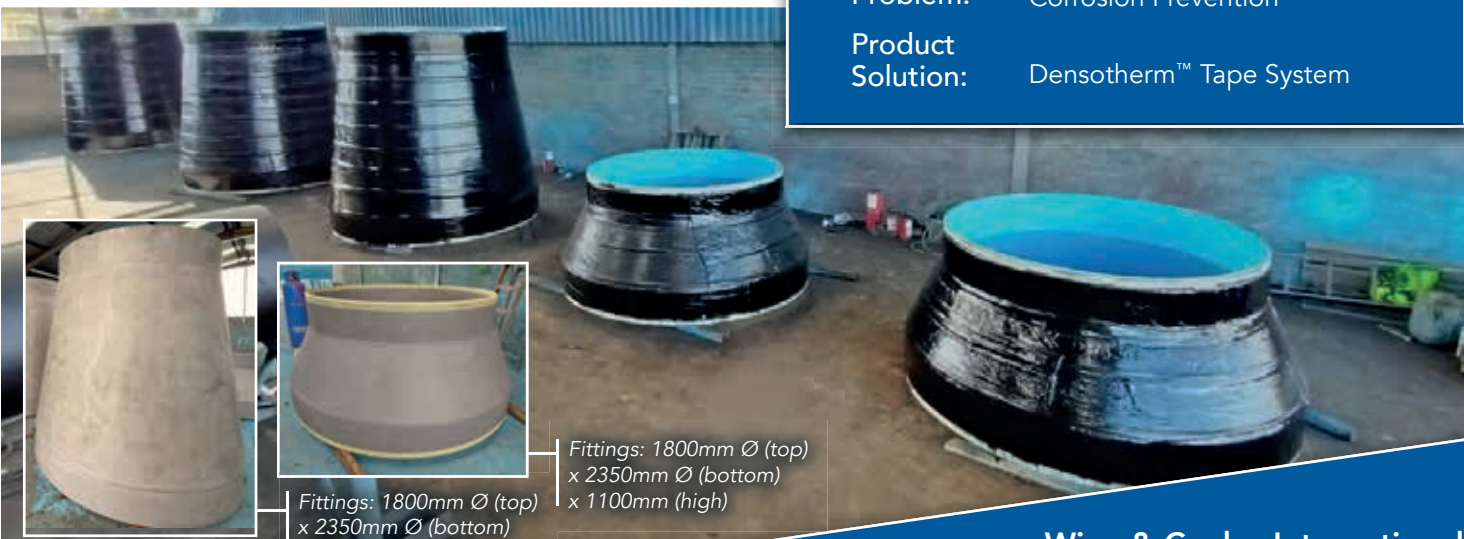
Fittings: 1800mm Ø (top) x 2350mm Ø (bottom) x 1100mm (high)  
 Fittings: 1800mm Ø (top) x 2350mm Ø (bottom) x 2350mm (high)

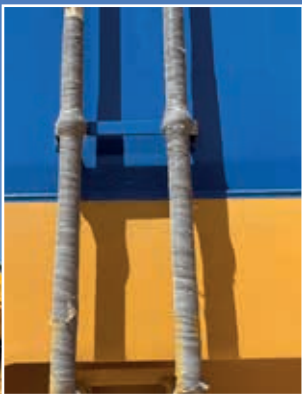
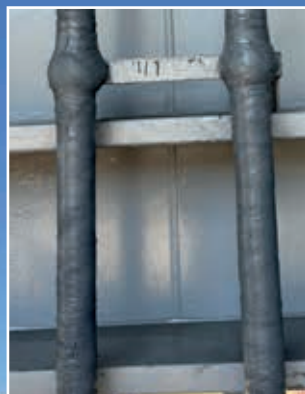
Inset pictures: various gas and water pipes protected with the modified Steelcoat 100/400™ System

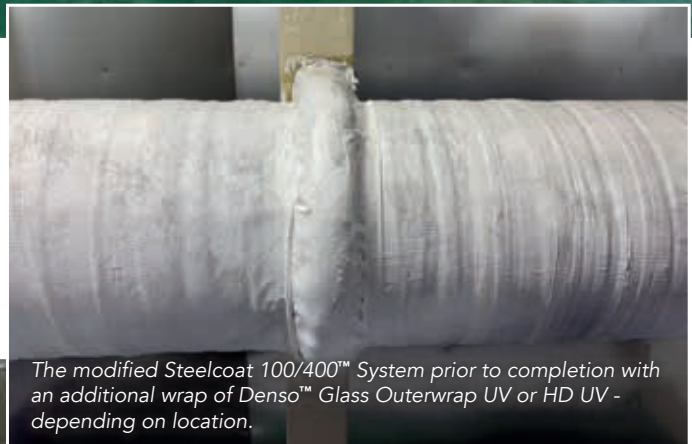
Secondly, the system has been modified for this application to include an additional wrap of Denso™ Glass Outerwrap UV (for exposed pipelines only situated above the water line) and Denso™ Glass Outerwrap HD UV (for submerged/splash zone pipelines alternating between above and below the water line). This enhanced system gives excellent impact resistance, capable of withstanding various potential collisions and impacts during operation, thus ensuring long-term reliable performance.

*The modified Steelcoat 100/400™ System prior to completion with an additional wrap of Denso™ Glass Outerwrap UV or HD UV - depending on location.*
